Initiation and short crack growth behaviour of environmentally induced cracks in AA5083 H131 investigated across time and length scales

Corrosion Reviews

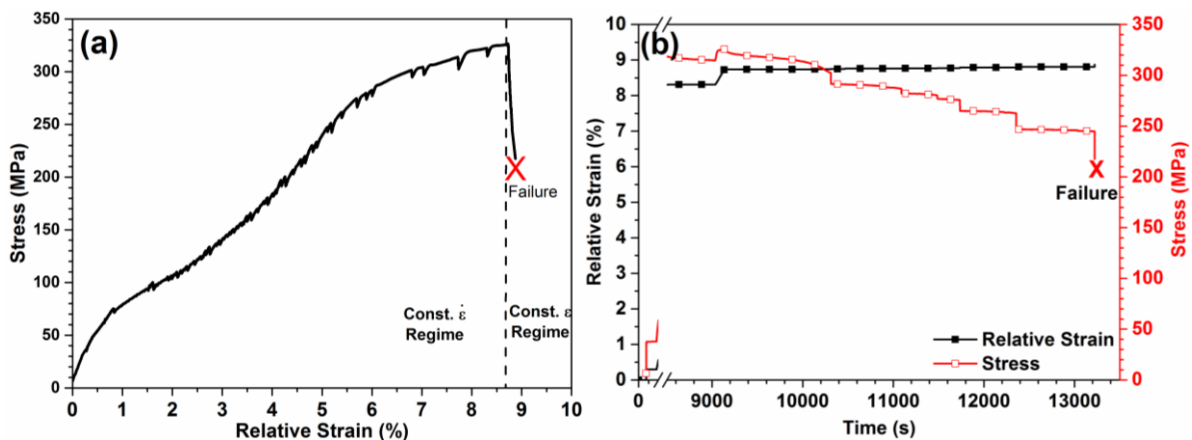
Figure 1: (a) Engineering Stress vs. relative strain response of the AA5083 sample, showing the region of switch from slow strain rate testing to fixed displacement testing, and the final failure. From 0 to ~3% relative strain, the plot displays a region showing the slack of the SSRT system; (b) Engineering stress and relative strain vs. test time showing the region of constant strain or fixed displacement highlighting the load drops observed until final failure.

The engineering stress vs. the relative strain from the SSRT of the sample tested is shown in Figure 1 (a). As can be seen, at around 325 MPa (close to UTS), the test was switched to constant strain or fixed displacement mode from the slow strain rate testing mode. Initially, the stress increases linearly with strain followed by yielding of the sample at ~275 MPa. After switching to fixed displacement mode at ~2.2% plastic strain, the stress across the sample drops from approx. 325 MPa to 225 MPa over a period of just over 4500 s as the EIC cracks grow leading to final failure. The stress vs. time during the fixed displacement regime of the SSRT is shown in Figure 1 (b). The drop in stress prior to failure was not immediate, but proceeded in a slow downward trend coupled with several small load drops.

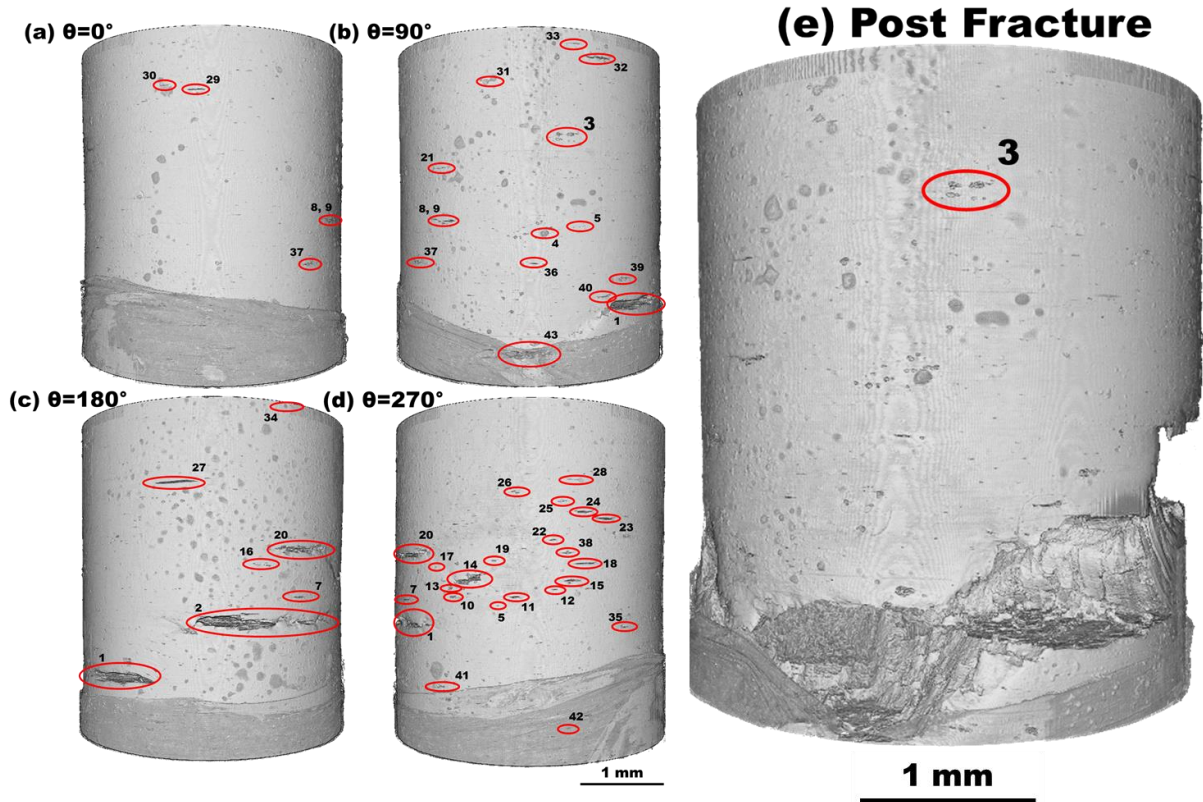
Figure 2: (a-d) Volume renderings of the gauge length of the sample at four different viewing angles (θ) obtained at a time step just prior to failure showing all the 44 EIC cracks that were numbered and investigated, and (e) volume rendering of the sample gauge length after failure showing the relative location of the specific EIC Crack marked “3” on the sample gauge length that was subject to further characterisation. The protective Parafilm™ used to prevent cracking outside the XCT field of view is also visible at the bottom end of the image.

Figure 2 (a)-(d) shows the sample just prior to failure and shows features such as the corrosion sites due to pre-exposure (covered by corrosion products in some locations) as well as the catalogued (numbered) EIC cracks, while the route of the final failure is shown in Figure 2 (e).

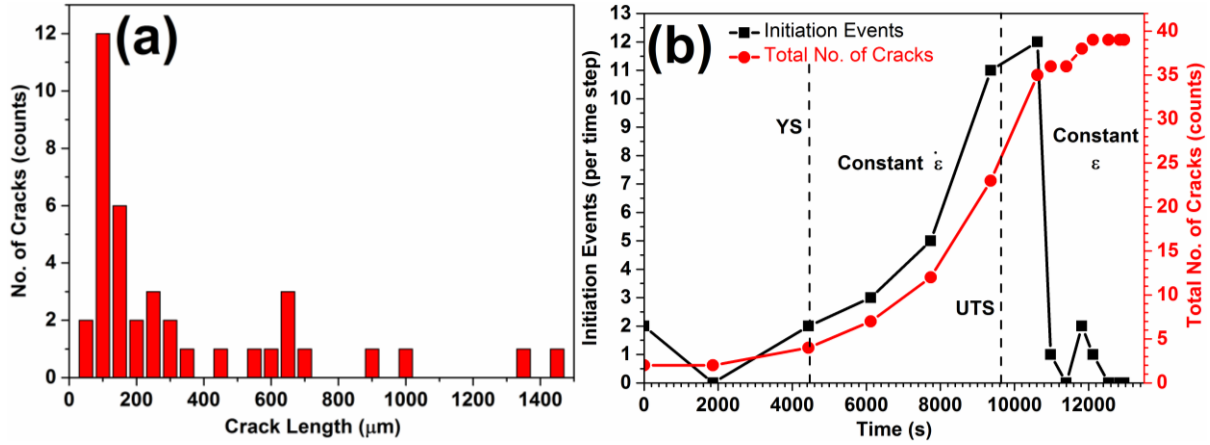
Figure 3: (a) Distribution of crack lengths in the sample measured from XCT data acquired just prior to overload failure (bin size = 50 μm), and (b) EIC Crack initiation events per time step, and total number of cracks as a function of test time (YS – Yield Stress, UTS – Ultimate Tensile Strength). All data measured from the reconstructed XCT images.

The number of EIC cracks measured from the XCT data acquired just prior to failure is shown in Figure 3 (a) as a function of the crack length. The engineering stress and plastic strain on the sample at this stage are ~ 245 MPa (post UTS) and $\sim 2.2\%$ respectively. The number of EIC crack initiation events, and the total number of cracks as a function of SSRT test time obtained from the time lapse XCT data is presented in Figure 3 (b). Crack initiation only starts at around 215 MPa (i.e. below yield), or after about 3700 s from the start of straining. The number of initiation events recorded gradually increases beyond yield point of the sample and drops sharply when the loading is changed to fixed displacement mode. Indeed, only four additional initiation events were observed after the switch to fixed displacement mode, although it is possible these cracks also initiated in the constant strain rate region and only grew large enough to be resolved by the XCT imaging slightly later. A total of 44 cracks were indexed and tracked through the test time and their size, location, and time of initiation were recorded within the spatial and temporal resolution limits. Of the 44 cracks that were indexed using the time-lapse XCT data, 5 minor cracks (< 50 μm), and 5 major cracks (> 50 μm , can

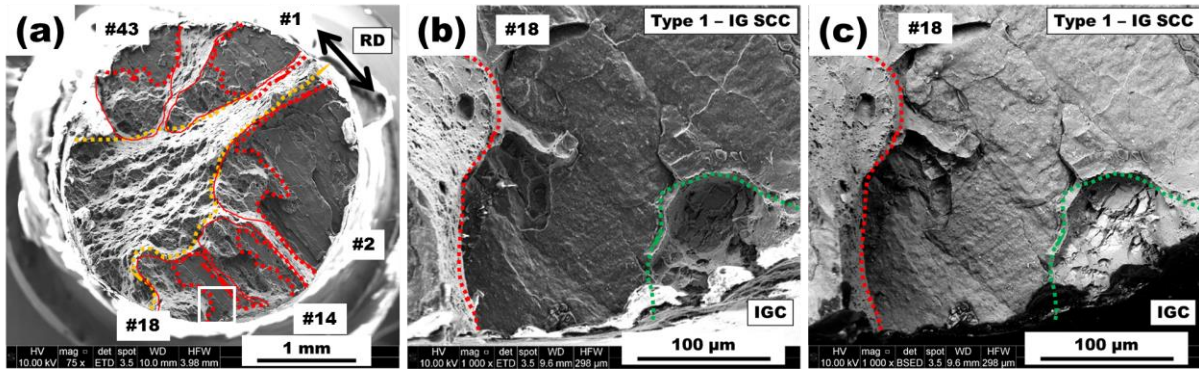
Figure 4: Secondary electron (SE) SEM images showing (a) overview of the fracture surface with IGSCC (Type 1, dotted red lines), Type 2 cracking (solid red lines), and multi-void coalescence (MVC, region within the dotted orange lines) along with the specific identified EAC crack numbers correlated from XCT data; (b) a closer look at the IGSCC (crack #18) fracture surface showing the region of initiation at a corrosion site (dotted green lines), and (c) Back scattered SEM image of region shown in (b) showing the bright appearing cluster of intermetallic phases at the surface corrosion site.

The fracture surface in Figure 4 (a) shows three major distinct regions displaying features corresponding to the IGSCC region (Type 1 fracture), Type 2 EIC, and micro-void coalescence (MVC) in addition to the surface corrosion sites. 35-40% of the fracture surface is identified as IGSCC which display a flat morphology which appears ‘shiny’ when viewed optically. Further, it is observed that the IGSCC regions are followed by Type 2 EIC cracking features characterized by their stepped topography and very large and shallow dimple-like features containing patches of particles (Holroyd *et al.*, 2017a). It is also observed that in all the instances, Type 2 EIC cracking is always preceded by Type 1 IGSCC. The total IGSCC area (Type 1) and Type 2 EIC area comprise approx. 60% of the fracture surface when viewed in plan view. The remaining 40% of the fracture surface is attributed to MVC that occurred

during the final stages of fast fracture and is characterized by the steep topography. Most of the IGSCC sites found on the fracture surface could be tracked back to features corresponding to surface corrosion sites. An example of this is presented in Figure 4 (b) (SE image) and (c) (corresponding BSE image) where a cluster of intermetallic particles (confirmed by SEM EDS to be AlFeMnSi based) at the surface of the sample gauge length have formed a corrosion site during the pre-exposure treatment in NaCl solution. This corrosion site is followed by IGSCC (Type 1 EIC cracking).

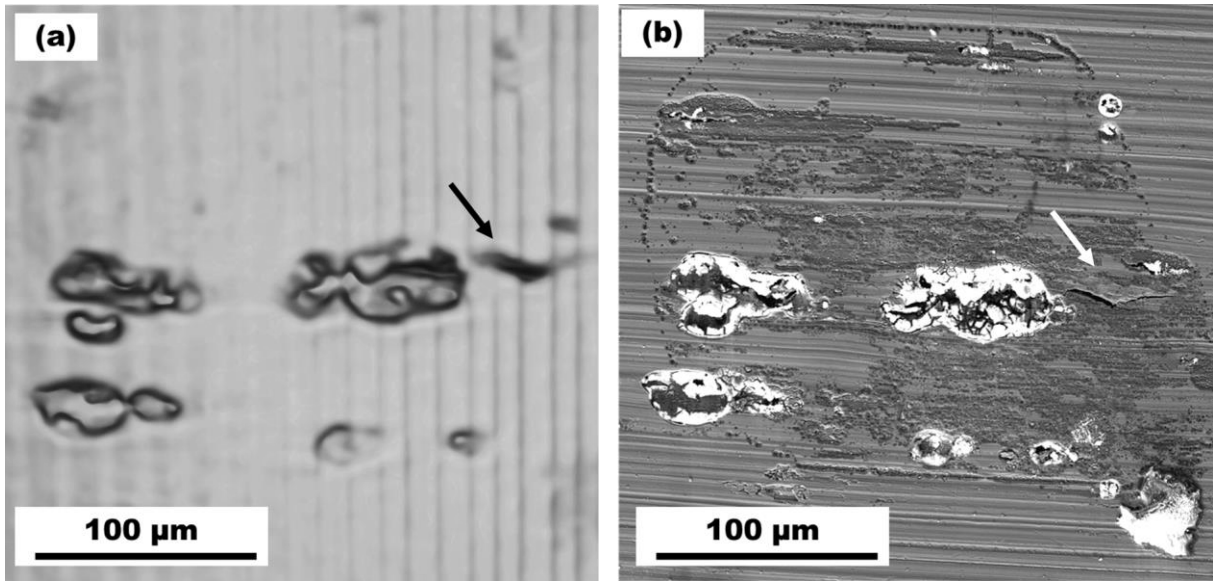
Figure 5: (a) Volume rendering of the sample gauge length surface obtained from the XCT data of the sample showing the region of interest where EIC Crack 3 (marked with black arrow) initiated, and (b) the corresponding SEM SE image of the surface showing the corrosion sites associated with intermetallic particles and the EIC Crack 3 (marked with white arrow) initiating from one of these sites.

Figure 5 shows the XCT surface rendering as well as the corresponding SE image of the corrosion site from where the crack 3 initiated. In Figure 5 (a), cracking can be seen to originate from the edge of one of the surface corrosion sites, which can be seen more clearly in the SE image in Figure 5 (b). Four distinct surface corrosion sites are visible. In addition, the SE image also shows corrosion products on the sample surface and general corrosion of the surrounding Al matrix, which is beyond the spatial resolution of the XCT images. EIC cracking can be clearly observed connecting to the edge of one of the corrosion site in the SE image in Figure 5 (b).

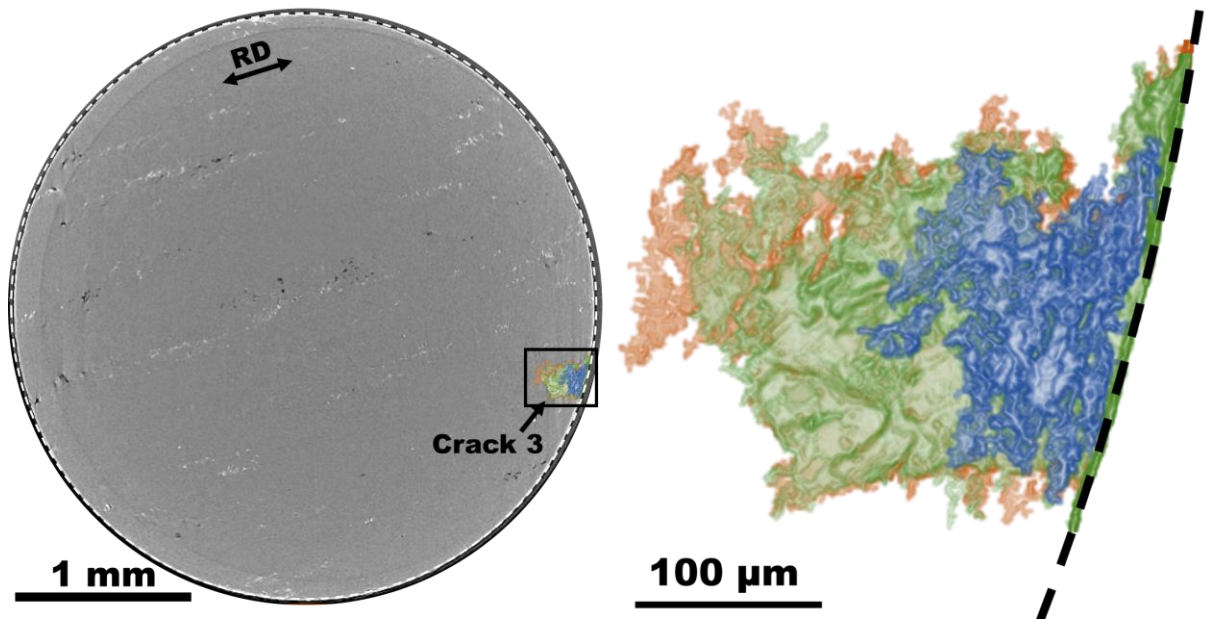
Figure 6: 3D volume renderings of the Crack 3 generated by segmenting the XCT data of the crack volume during slow strain rate testing (blue crack $t = 8460$ s) at the transition to constant displacement (green crack $t = 9480$ s) and after a period of constant displacement just before the final failure of the specimen (orange crack $t = 13080$ s).

In order to better visualise the growth of the crack, the 3D XCT volume of the crack was segmented and visualised at various stages of the test as shown in Figure 6. It is clear that there were no major changes to the crack length and morphology under fixed displacement conditions, indicative of minimal EIC propagation for this crack.

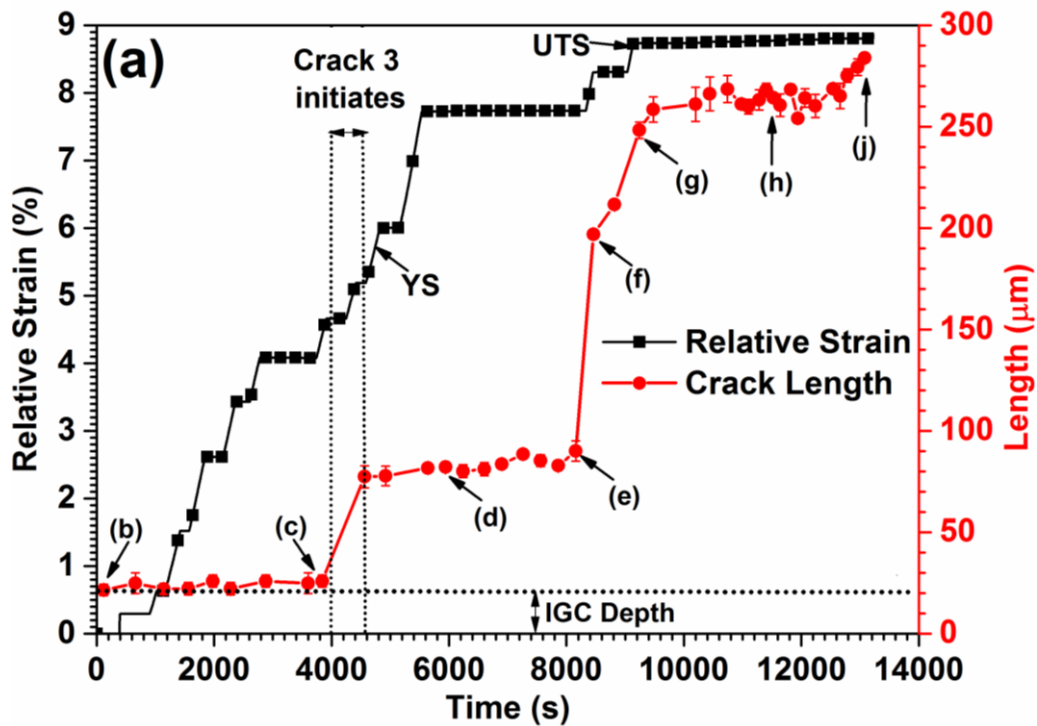
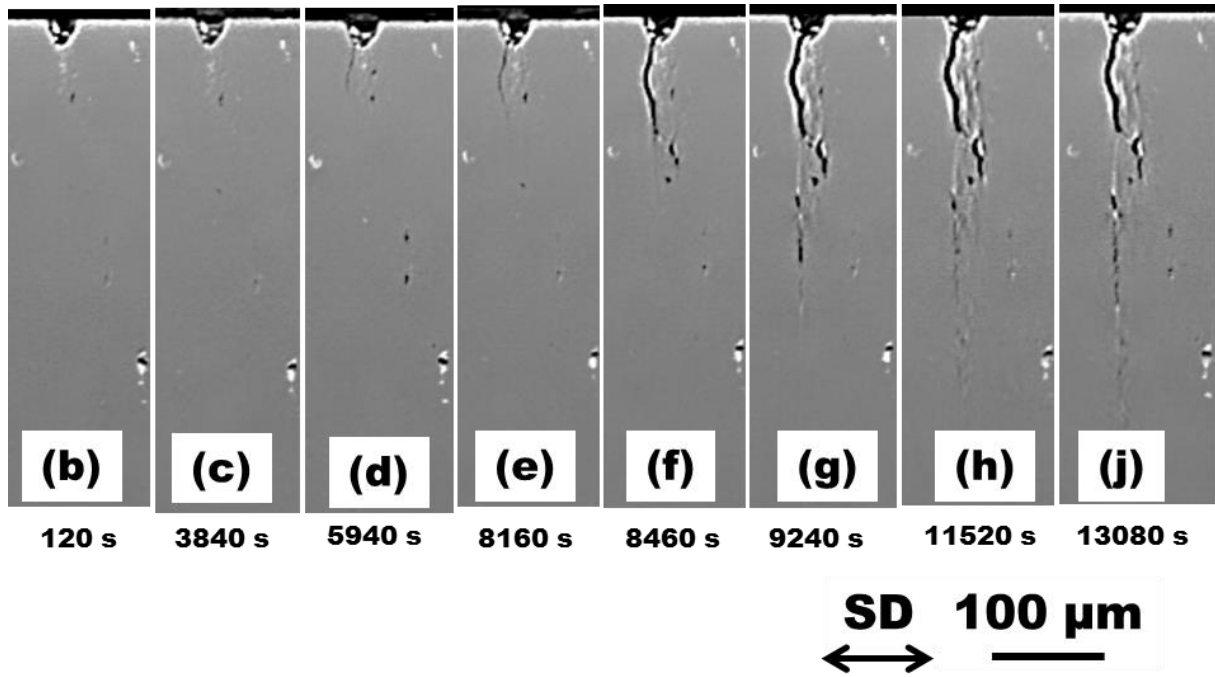
Figure 7: (a) Length of ‘crack 3’ measured from the time lapse XCT data, and calculated relative strain on the sample vs. test time showing - 0.2% Yield strength – 275 MPa, Initiation window of the crack 3, UTS – 325 MPa, and the initial IGC site depth; (b-j) XCT virtual slices of the sample showing the crack at various stages of the test marked in (a). SD – straining direction.

The crack length and the relative strain on the sample vs. the test time, are shown in Figure 7 in addition to selected XCT virtual slices of ‘crack 3’ shown at different time steps. The initiation of crack 3 occurred from a 30 μm feature (to be discussed later) between $t = 3800$ s - 4500 s (Figure 7). The crack appears to grow visibly in the early stages before growing quite abruptly. The virtual slices of the cross section of the crack from time lapse XCT data shown in Figure 7 (b)-(j) reveal the growth as well as the changes in path of the crack before appearing to become dormant in the fixed displacement regime. Lastly a small slow increment of growth is observed just before sample failure. The highly branched nature of the crack is observed in the Figure 7 (f)-(j). The stepwise increase in the strain is due to the intermittent loading of the sample that was employed prior to yielding to allow steady state conditions during XCT acquisition. Beyond a plastic strain value of ~2% ($t = \sim 5500$ s) the first instance of fixed

displacement was applied. During this period no crack growth was observed in the sample after over 1 hour, therefore it was decided that the load at fixed displacement was too low and displacement was increased in a further step (at $t = \sim 8000$ s). Following this, crack growth occurred registering both in the mechanical response of the sample and the raw 2D X-ray projections. In the subsequent analysis of the 3D data a rapid increase in the crack length is evident. A further increase in strain (at $t = \sim 9000$ s) was followed by another increase in crack length. This step-up in load was performed to allow growth of the crack under subsequent fixed displacement mode in a reasonable amount of test time. During the fixed displacement stage ($t > \sim 9000$ s) it is observed that the crack did not propagate for a period followed by a small, slow increment in length. The largest growth occurred during the reloading step at $t = \sim 8000$ s. In addition, most of the instances of change in length of the crack can be correlated to the change in strain on the sample due to applied load change. The implications of this method of testing will be discussed later.

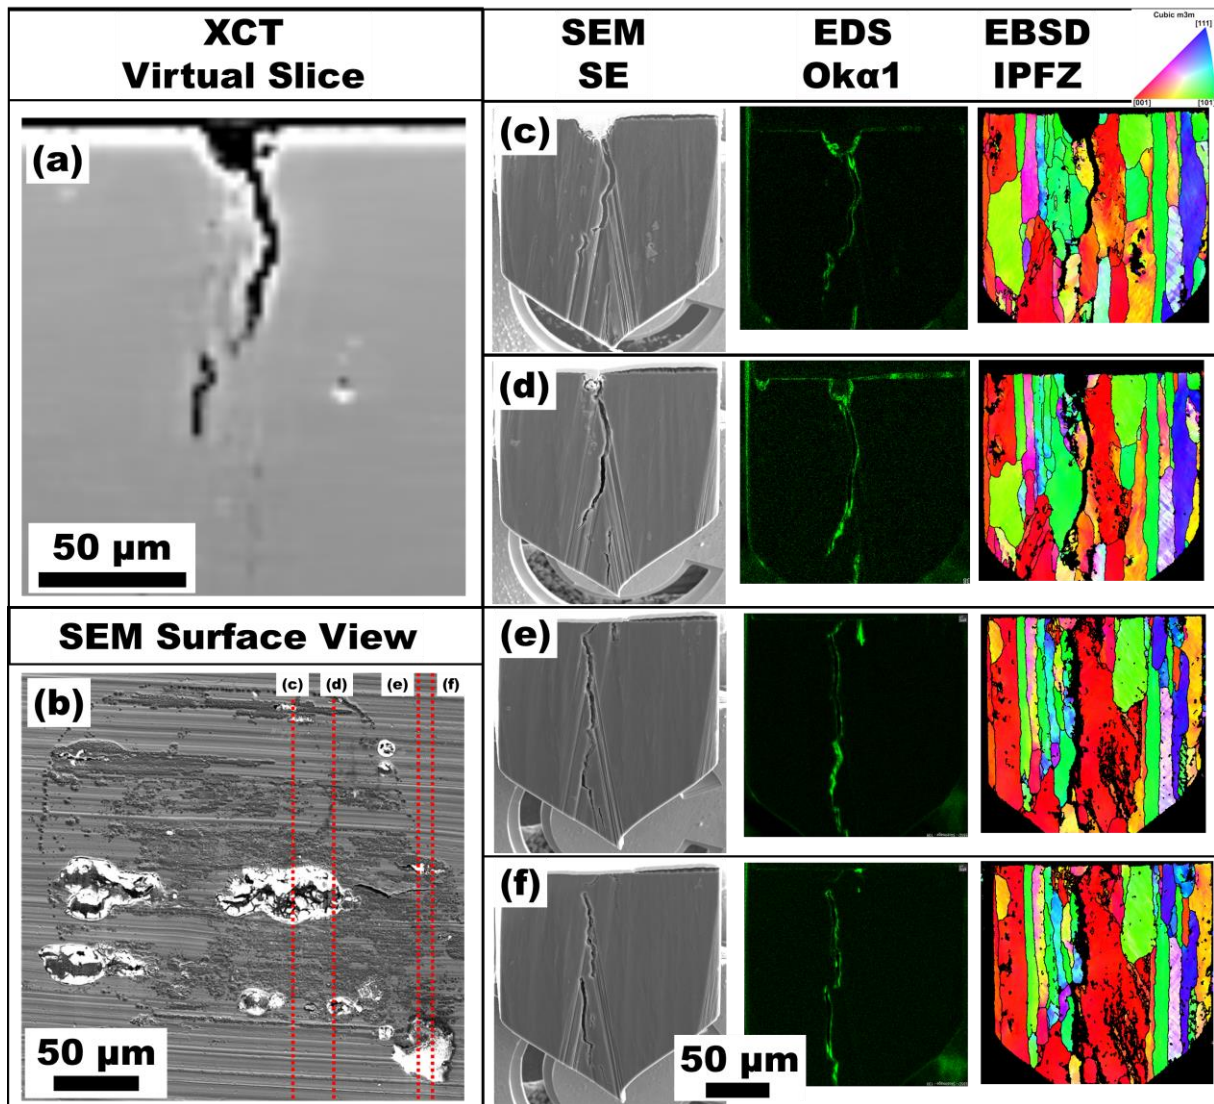
Figure 8: (a) XCT Virtual slice (filtered) showing initiation region and morphology of ‘crack 3’, (b) SEM SE surface view of the corrosion site from where the crack initiated showing the locations (marked in red) of the presented PFIB cross-sections (c)-(f) from which SE images, EDX and EBSD maps were acquired. Slice (c) corresponds to the XCT virtual slice in (a)

Post-mortem characterization of 'crack 3' was conducted in order to better understand the interaction of this crack with the microstructure. EDS elemental and EBSD mapping were employed to relate the crack path to the local grain orientations and the nature of any local second phases. Selected SEM SE images, corresponding EDS O $K_{\alpha 1}$ maps and EBSD IPF Z maps from this analysis are presented in Figure 8.

The local microstructure and chemistry of the region neighbouring ‘crack 3’ is shown in Figure 8 via 4 PFIB sections. The SEM SE images in Figure 8 (c) and (d) appear to show the crack originating from the bottom of the corrosion site, while that in Figure 8 (e) shows that the crack has followed a grain boundary which is at a $\sim 45^\circ$ angle to the surface. Some of the sharp changes of direction of the crack near the surface were initially thought to be tears through ligaments between different crack regions. However, the corresponding EBSD

orientation maps show that in all instances the crack is propagating along grain boundaries, as expected due to the IGSCC or Type 1 nature of EIC. Close to the initiation site, the crack path is more tortuous as it follows the grain boundaries, but as the crack develops it becomes more planar as it follows the boundary of the large (red) grain that extends almost throughout the entire volume to the right of the crack in Figure 8 (e) and (f). It appears that this large grain leads an interconnected high angle grain boundary with a number of neighbouring grains across the entire 3D volume, providing a direct route for crack propagation in the most mechanically favourable direction. The highly disjointed nature of these first increments of crack growth and the fact that the further along the length of the crack (deeper into the material) the crack opens up, leads us to believe that several very small cracks originally initiated from the particle cluster. It is surmised that with further growth these small cracks then coalesced leading to the opening of the crack and continuation as a single larger crack.
