EFFECT OF “475°C EMBRITTLEMENT” ON THE CORROSION BEHAVIOUR OF GRADE 2205 DUPLEX STAINLESS STEEL INVESTIGATED USING LOCAL PROBING TECHNIQUES

C. Örnek¹, D.L. Engelberg¹, S.B. Lyon¹, T.L. Ladwein²

¹ Corrosion and Protection Centre, University of Manchester, Sackville Street, M13 9PL, UK

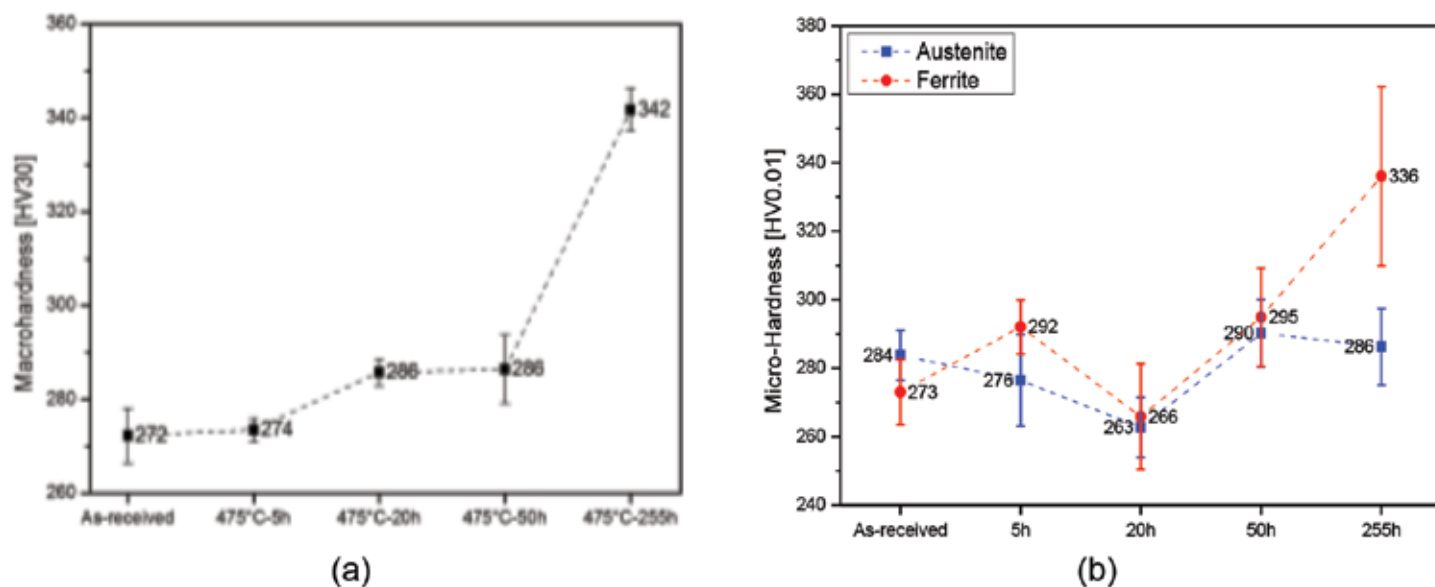
Figure 3: (a) Macrohardness of bulk material, (b) microhardness of austenite and ferrite; dashed lines in both diagrams indicate possible trend.

Macro- and micro-hardness measurements are summarised in Figure 3. The increase in macro-hardness with aging times indicates changes in the microstructure; given the heat treatment conditions this can be attributed to the occurrence of 475°C embrittlement. A significant increase after 255 hours of ageing was observed. A similar trend was observed in the micro-hardness measurements. Aging of

up to 50 hours at 475°C seems not to cause significant hardness changes, but an increase in the micro-hardness of the ferrite after 255 hours is noticeable. Interestingly, the austenite did not show an increase in hardness.
