The effect of additive 'depositional' reprofiling of compressor blade leading edges on engine performance

GT2024-128846

THE EFFECT OF ADDITIVE ‘DEPOSITIONAL’ REPROFILING OF COMPRESSOR BLADE LEADING EDGES ON ENGINE PERFORMANCE

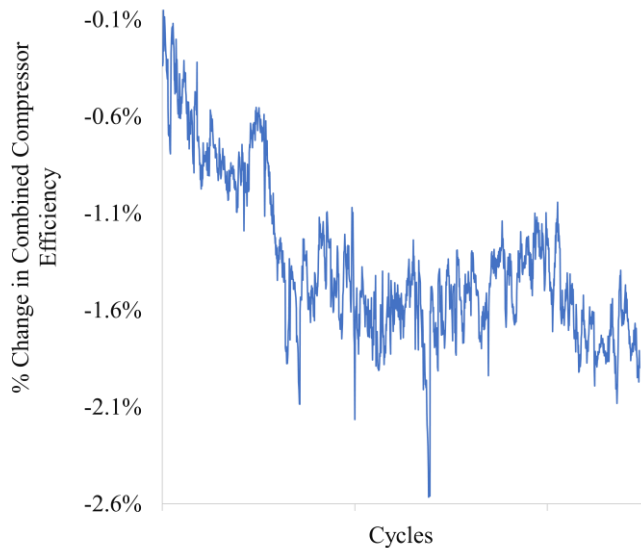
FIGURE 2 – THE CHANGE IN COMPRESSOR EFFICIENCY (I.E. THE FAN, IPC AND HPC COMBINED) OVER THE FIRST ~1200 CYCLES OF THE TEST

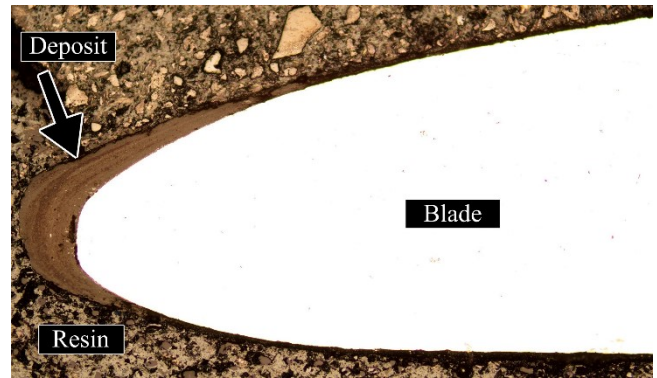
FIGURE 3 – AN EXAMPLE OF A LEADING-EDGE DEPOSIT FROM THE SERVICE ENGINE, SHOWN IN CROSS-SECTION DISPLAYING THE SHAPE AND SURFACE ROUGHNESS OF THE DEPOSIT ALONG WITH THE LAYERING PRESENT THROUGHOUT ITS THICKNESS

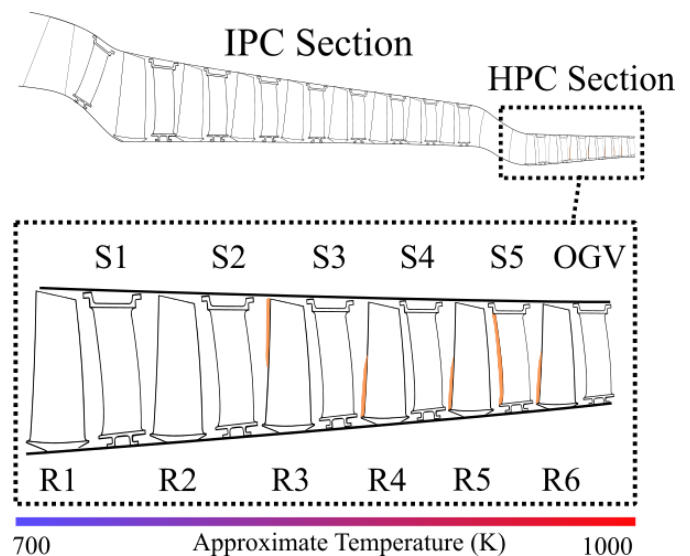
FIGURE 4 - A SCHEMATIC OF THE ENGINE USED IN THE TEST, WITH APPROXIMATE TEMPERATURES. THE HPC SECTION IS HIGHLIGHTED TO INDICATE THE LOCATIONS WHERE DEPOSITS WERE OBSERVED ON THE TEST ENGINE COMPONENTS. DEPOSIT PATTERNS AT EACH STAGE WERE CONSISTENT AROUND THE ENGINE ANNULUS.

Figure 4 shows the distribution of the leading-edge deposits on the test engine components in the HPC. The leading-edge deposits formed within the HPC were found towards the tip of rotor 3 (R3), but for R4, R5 and R6, deposits were only present towards the hub. Stator 5 (S5) was the only stage of stator vanes to develop significant leading-edge deposits and in contrast to the rotor blades, they were found along the full length of the components. Qualitatively, little variation in the deposit distribution around the annulus was observed at each stage. In this study, a single component was selected from HPC R5, R6 and S5 to allow comparison of the leading-edge deposits formed (a) on two different rotating components, and (b) on rotating and stationary components.

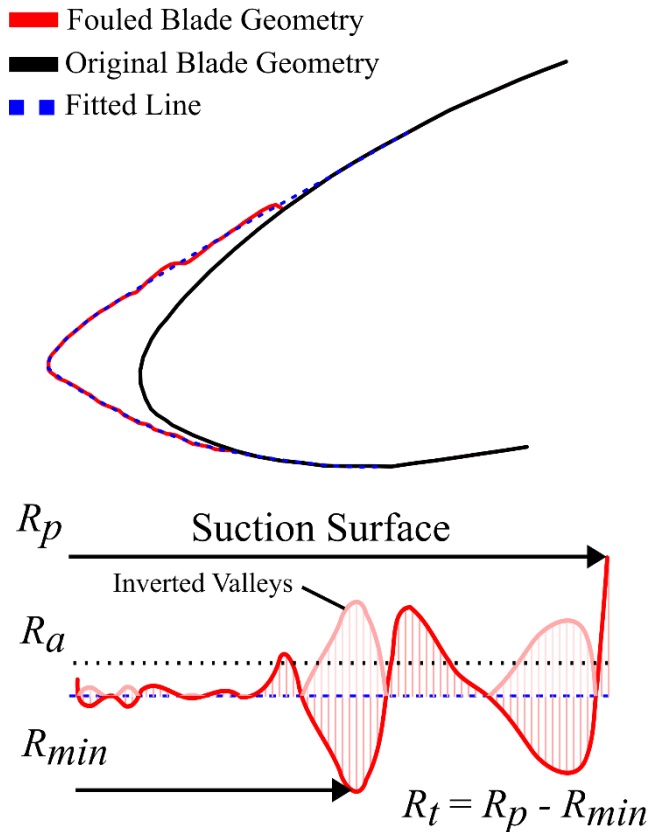
FIGURE 8 – THE METHOD USED TO EVALUATE DEPOSIT SURFACE ROUGHNESS, SHOWING THE 8TH ORDER POLYNOMIAL FIT DESCRIBING THE SHAPE OF THE DEPOSIT SURFACE (FITTED LINE), AND THE PARAMETERS USED TO DESCRIBE THE DEVIATION OF THE ACTUAL SURFACE OF THE DEPOSIT FROM THE FIT

Surface roughness is here determined from the deviation of the actual surface of the deposit from a smooth fit that describes the shape of that surface (see Figure 8). By trial-and-error it was found that an 8th order polynomial provides a good description of the shape of the original unfouled pressure and suction surfaces around the leading edge, and so an 8th order polynomial was used to obtain an empirical description of the topography of the pressure and suction surface deposits around the leading edge. The distance between the fitted line and the actual deposit surface (orientated perpendicular to the chord line) was then measured in 5 μm intervals around the leading edge for each

of the suction and pressure surfaces to produce the type of plots shown in Figure 8. Using an approach similar to that of [16], from this plot three parameters providing a measure of surface roughness were evaluated: the average height of the deposit from the fitted line (R_a), the magnitude of the peak that deviates most from the line of fit (R_p), and the distance between the tallest peak and the deepest valley of the deposit surface (R_t).

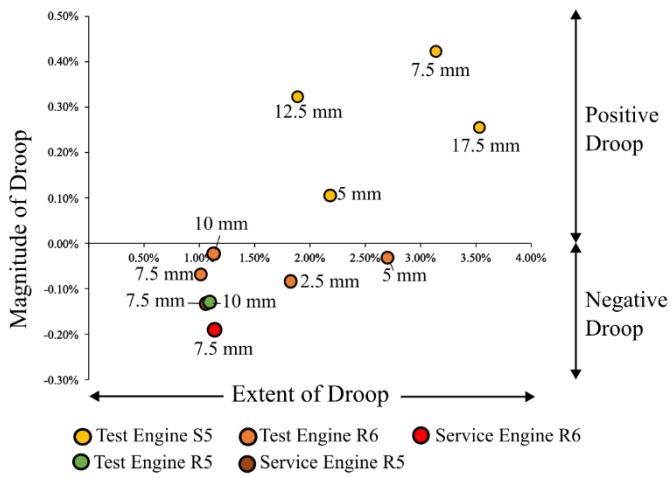
FIGURE 11 – THE EXTENT OF DROOP AGAINST THE MAGNITUDE OF DROOP FOR THE TEST ENGINE S5 AND R5,6 AND SERVICE ENGINE R5,6 WITH LABELS SHOWING THE HEIGHT OF THE SECTION ALONG THE COMPONENT

The change in geometry of test engine S5 caused by the leading-edge deposits shows that the deposits form preferentially on the pressure surface (Figure 10A) and have positive droop (Figure 11). The magnitude of droop ranges from 0.1% to 0.42% while the extent of droop ranges from 1.88% to 3.53%. Figure 11 also shows that there is no correlation within the data set between the magnitude of droop and extent of droop. The increase in leading-edge sharpness on test engine S5 ranges from 10% to 33% for the sections analyzed; the section at 5 mm from the hub wall was not included in this data since the deposit did not lie over the leading-edge point of the unfouled blade. Average R_a values over the pressure and suction surfaces of test engine S5 are $6.1 \mu\text{m}$ and $4.5 \mu\text{m}$, respectively. The surface roughness of the S5 section taken 7.5 mm from the hub shows that the largest peak in surface roughness is on the pressure surface, where the deposit blends into the component (Figure 12). Although there is limited data available, there is no correlation shown between the position along the vane where the section was taken and any of the measured parameters.

The change in geometry of test engine R6 caused by the leading-edge deposits shows that unlike S5, the deposits develop preferentially on the suction side of the rotor (Figure 10B) and have negative droop (Figure 11). The magnitude of droop ranges from -0.02% to -0.08%, which is significantly smaller than on S5, with less spread of the data. The extent of droop is also typically smaller than S5, ranging from 1.01% to 2.70%. The increase in leading-edge sharpness caused by leading-edge deposits ranges from 18% to 45% across the component, which was slightly greater than on S5. R_a values for test engine R6 are similar on both sides of the component, with average values on the pressure and suction surfaces at

The leading-edge deposits from service engine R5 and R6 blades both have negative droop (Figure 11), like both rotors from the test engine. The magnitude of droop is similar on both service engine R5 (-0.13%) and R6 (-0.19%) sections, but these values are significantly larger than those obtained from the test engine rotors. The extent of droop is similar between service engine R5 (1.08%) and R6 (1.14%) and this lies within the range of the data from the test engine. The R5 section from the service engine only exhibited a 1% change in the leading-edge sharpness, the smallest value of all the component sections. The service engine R6 section has a sharpness value within the range of that obtained from the test engine sections, suggesting that the R5 result is possibly an outlier rather than an indication of different results in the two engines. The service engine R5 and R6 surface roughness parameters are similar to those of test engine R5 and are significantly smaller than the test engine R6 and S5 values. Compared with the test engine deposits, the service engine deposits blend in more smoothly to the component (Figure 12).

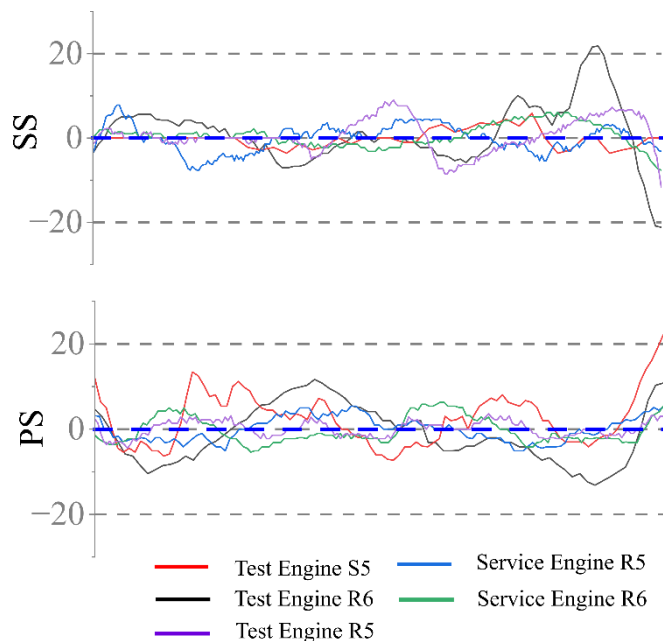
FIGURE 12 – THE DEPOSIT SURFACE PROFILES FOR SELECTED COMPONENTS ALL TAKEN FROM APPROXIMATELY THE SAME HEIGHT ALONG THE BLADE/VANE.

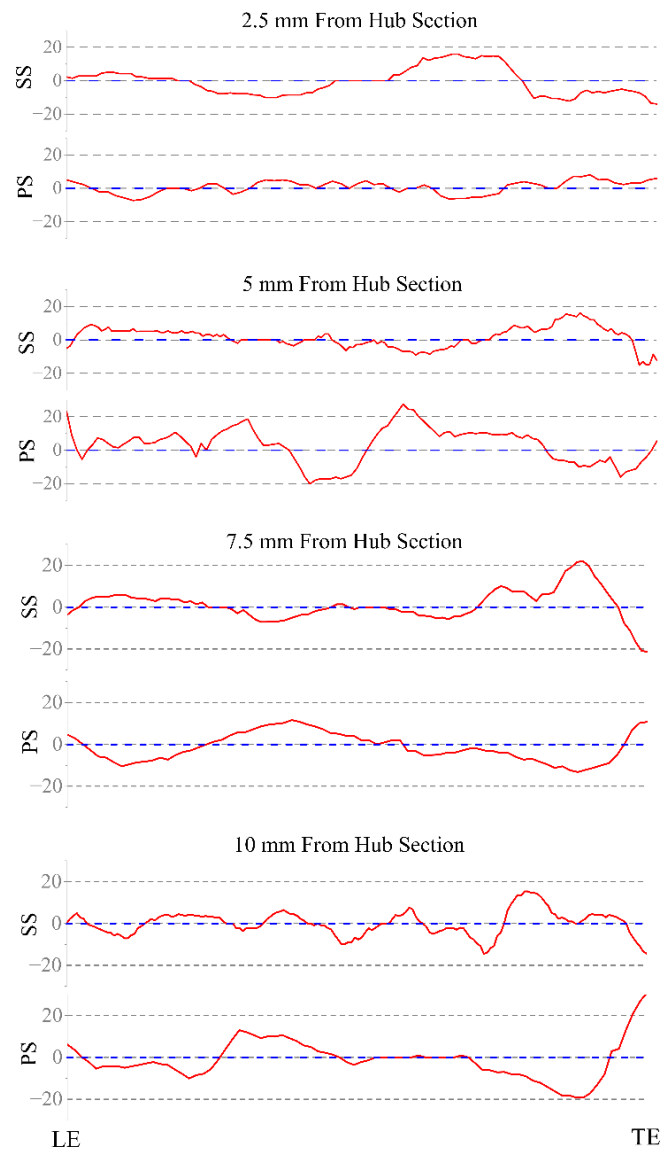
FIGURE 13 – THE DEPOSIT SURFACE PROFILES FOR EVERY SECTION EXAMINED ALONG TEST ENGINE R6. SS IS SUCTION SIDE; PS IS PRESSURE SIDE

$6.7 \mu\text{m}$ and $5.5 \mu\text{m}$ respectively, also similar to S5. A plot showing the change in roughness over both surfaces of test engine R6 along the length of the component shows that consistently large values of deviation from the fitted line occur at the end of the deposit on both pressure and suction surfaces, where the deposit blends into the component (Figure 13). Again, like S5, no correlation is found between the height of the section and any of the measured parameters.
