Effect of Microstructure on Atmospheric-Induced Corrosion of Heat-treated Grade 2205 and 2507 Duplex Stainless Steels

Cem Örnekk^{1,2}, Amina H. Ahmed¹ & Dirk L. Engelberg^{1,2}

Abstract

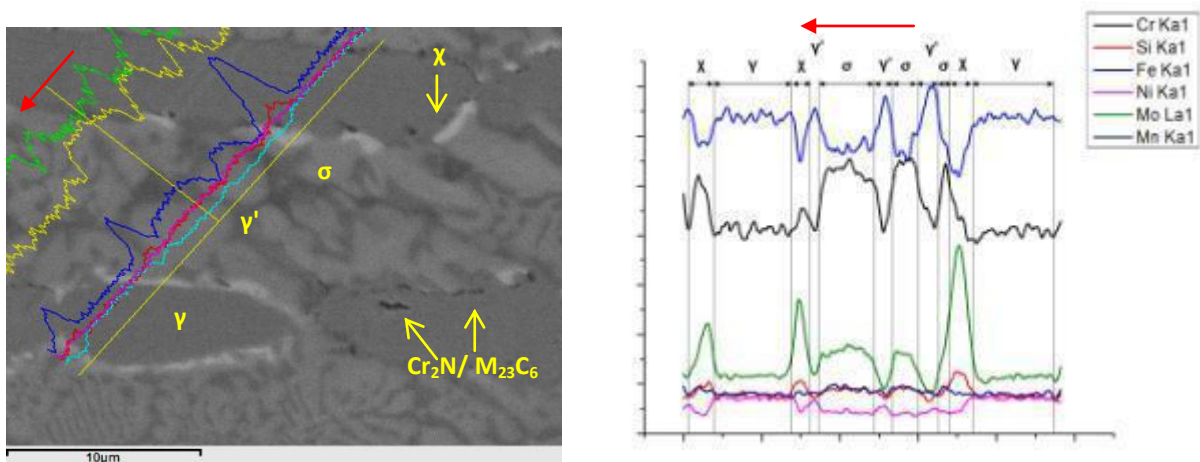
Fig. 2: Backscattered-SEM image with EDX line scans of heat-treated 2507 (750°C/3h).

Fig. 1 (d) shows the microstructure of heat-treated grade 2507, and Fig. 2 summarises additional EDX line profiles. The brightest regions (α/γ -interface) contain significantly increased Cr (26-30%), Mo (13-18%), and Si (0.9-1.3%) contents, related to χ -phase. The σ -phase in this microstructure has higher Cr (30-33%) contents, with less Mo (4-7%) and Si (0.6-0.7%). Austenitic grains are still apparent, but no ferrite was observed in the region investigated. However, ferrite may have transformed into smaller islands and the presence of remaining ferrite in the microstructure cannot be excluded.

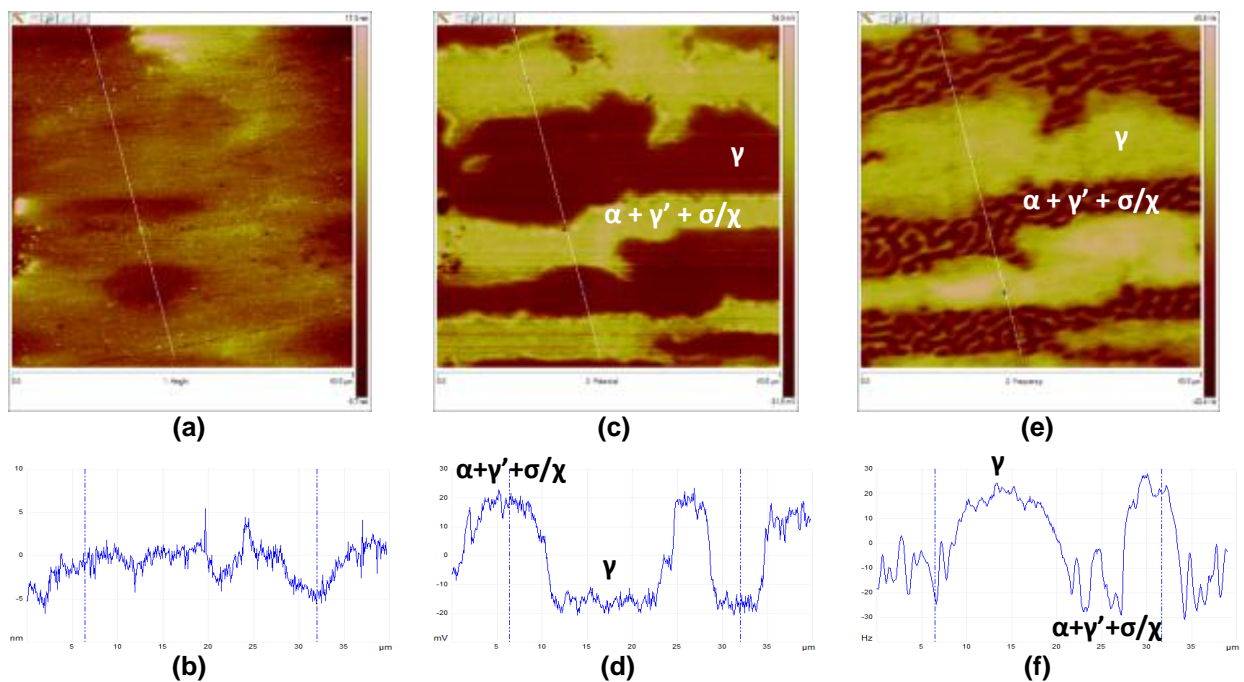
Fig. 6: Heat-treated grade 2205 (750°C/3h) (a-b) surface topography map and profile; (c-d) $\Delta\psi$ map and profiles; (e-f) ΔMf map and profiles.

Fig. 6 shows the $\Delta\psi$ and ΔMf values of heat-treated grade 2205. The surface potential image seems more diffuse around the edges of the individual phase boundaries (Fig. 6 c), which is also reflected in the MFM image (Fig. 6 e). Interestingly, along the austenite/ferrite phase boundary, gradual transitions in ΔMf can be seen, in comparison to a steep transition in the as-received microstructure. It may be inferred that once significant elemental depletion occurred, for example due to the precipitation of secondary phase, changes in $\Delta\psi$ and ΔMf may take place. Second phase precipitates were only observed in heat-treated microstructures,

Distinctive ΔMf variations within the ferrite are possibly related to changes in the magnetic domains, indicating regions with locally different magnetic behaviour (Fig. 6 f). Ferrite has higher $\Delta\psi$ values and is therefore expected to behave as a net anode, which was also observed in our AIC tests of heat-treated grade 2205. The $\Delta\psi$ values measured by SKPFM in air seem to correlate with the atmospheric corrosion behaviour of the as-received and heat-treated grade 2205. Information obtained in this study will be used to set-up and characterise microstructure for in-situ AISCC testing at temperatures more relevant to ambient exposure conditions, i.e. at temperatures below 50°C.
