Interfacial aging in composite insulators as a result of partial discharge activity

Pablo D. Bastidas and Simon M. Rowland
School of Electrical and Electronic Engineering
The University of Manchester
Manchester, United Kingdom
s.rowland@manchester.ac.uk

Abstract—High voltage outdoor composite insulators used on transmission lines can be subject to degradation due to electrical discharge activity at the core-sheath interface. A methodology is described to explore the effect of de-bonding or loss of adhesion between the sheath and core in composite insulators. The use of planar geometry materials allows interfacial pressure to be varied and facilitates physical and optical imaging of the tracking as it grows and chemical analysis of the samples after aging. The associated electrode geometry allowed the tracking to develop in a constant field, unaffected by the earth electrode. Low pressure between the materials accelerated the growth the tracks. A correlation between partial discharge magnitude and track development is identified. Electrical tree growth was also observed penetrating the epoxy resin, initiated from the interfacial tracks.

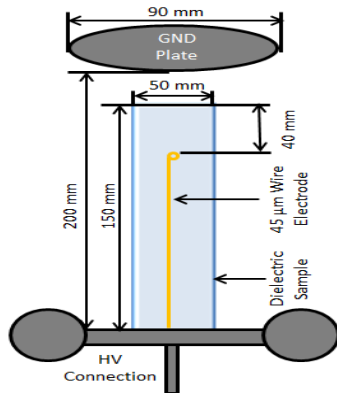
Figure 1. Schematic of the experimental set-up (top view). Not to Scale.

A photograph of the experimental system and a schematic of the electrode configuration is presented in Figures 1 and 2. The distance between the tip of the wire hook and the ground plate was fixed at 90 mm for all the tests presented here. The gap distances and geometries of external electrodes were designed using FEA to prevent surface discharges. A feature

of the test geometry is that the earth electrode is planar and always distant from the tracking. As a result damage was not accelerated by field enhancement as the track approached a ground electrode, as is often the case in laboratory tests.

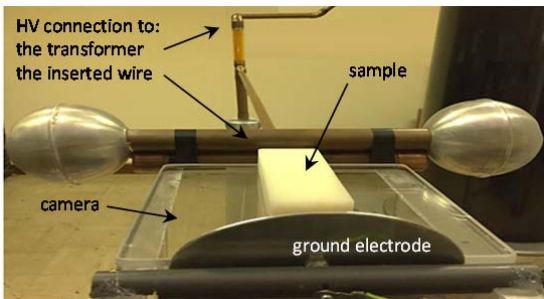
Figure 2. Experimental facility used to investigate interfacial aging in planar insulating samples

temperature vulcanized SiR. A 45 μm diameter stainless steel wire was placed between the dielectrics, which were then pressed together with a force of up to 60 kPa. The wire formed an electrode which enhanced the local electrical field and was found to reproducibly initiate partial discharge activity. The EP was fabricated using Araldite-LY5052 resin and Aradur-HY5052 hardener mixed in the ratio of 100:38 by weight. The mixture was then degassed in a vacuum chamber before being dispensed into a frame over a 1 mm thick polycarbonate sheet. The resulting plaque had a smooth surface finish, with a surface roughness of $\sim 0.3 \mu\text{m}$, whilst the SiR plaques had a surface roughness of $\sim 0.7 \mu\text{m}$. The samples were assembled as follows: the wire and the SiR plaque were cleaned with propanol, whilst the epoxy was rinsed with deionised water. Both plaques were immediately blown dry with warm air to avoid leaving surface stains. The tip of the wire was formed into a circular shape (a crook) of $\sim 1.2 \text{ mm}$ diameter which was then placed between the dielectrics, forming a controlled field enhancement 40 mm from the sample's short edge. This is illustrated in Figure 1. The assembly was orientated with the large planes horizontal. It was supported on a glass plate, with the transparent epoxy resin adjacent to the glass so that images of degradation and light emission could be obtained from the underside, whilst a dead weight could be used to impose controlled pressure from the top.

Bricks ($\epsilon_r = 6$ to 8) were used as weights to vary the mechanical pressure on the samples. This ranged from 0 to 60 kPa. To monitor the interfacial activity, partial discharge (PD) magnitudes and the partial discharge inception voltage (PDIV) were recorded using an Omicron MPD600 measurement system. A camera (Canon EOS-1100D) was used to monitor the progression of visible aspects of degradation. AC voltages up to 32 kV were applied to the HV connection (RMS voltage values are exclusively used in this paper).

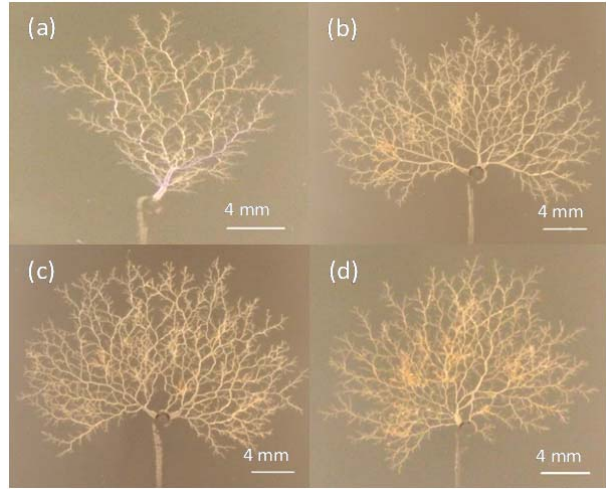
Figure 3. Development of interfacial channels at (a) 0 kPa, (b) 20 kPa, (c) 40 kPa and (d) 60 kPa

Figure 3 gives examples of the visible interfacial channels grown at various mechanical pressures. As can be seen, the structure, color and width and length of the tracking pattern are similar for each sample. Table I shows the measured partial discharge inception voltage. The inception voltages are consistent around 4.5 kV, but the PD inception magnitudes decrease when the mechanical pressure is increased (the PD magnitude is halved by increasing the pressure from 0 to 60 kPa). This is thought to be due to voids around the wire being closed up at higher pressures. However, it was observed that when the voltage was increased to 30 kV, PD magnitudes were measured of 65 pC at 0 kPa, and 103 pC at 60 kPa, yet at pressures of 20 and 40 kPa, PD magnitudes were recorded above 450 pC: an observation not yet explained.

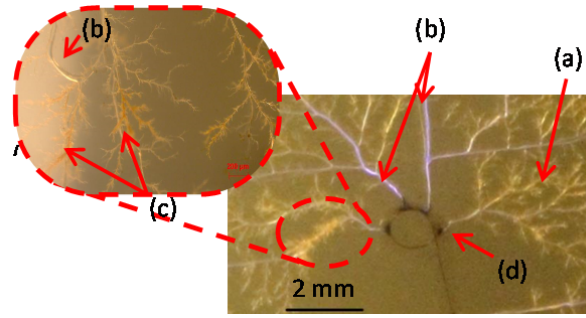
Figure 5. Microscopy of the cross-section from the test at 40 kPa. (a) interfacial channels, (b) main branches, (c) electrical trees and (d) carbon conductive deposits. Active discharges in (b) color the branches purple.

A key feature of the tracks is whether they are growing in the interface, or in either of the bulk materials. The distinctive interfacial branches are shown in Figure 5. In the geometry tested, tracks developed as trees into the epoxy resin, although this was not seen in the silicone rubber. This is consistent with reports reviewed previously [14],[15]. Figure 6 shows polished cross-sections of the epoxy resin plaques that were observed under an optical microscope. Each sample shows the characteristics and dimensions of the trees which propagated into the bulk of the epoxy. Higher pressures appear to encourage growth of electrical trees into the epoxy resin as reported by Kobayashi et al [15]. This is likely to be due to a reduced tendency to grow within a pressurized interface. At 0 kPa the main channels at the

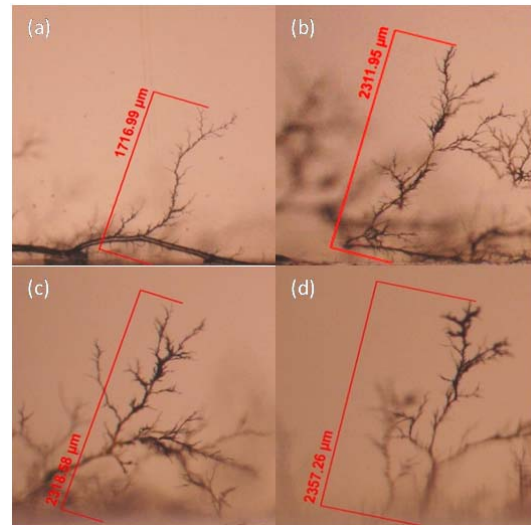
Figure 6. Comparison of the largest electrical trees that grew into the EP plaques (a) 0 kPa, (b) 20 kPa, (c) 40 kPa and (d) 60 kPa.

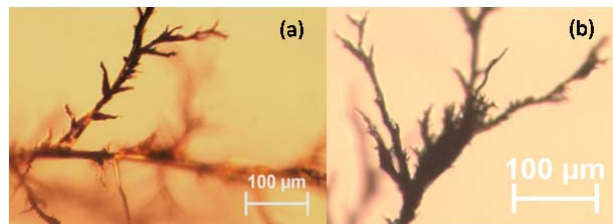
Figure 4. The structure of the branches developed in the epoxy at 60 kPa.
 (a) the carbon deposits on the walls of the channels,
 (b) the tips of the branches

interface are wider and in the epoxy small amounts of carbon deposits can be seen at the walls of the hollow channels and also at the tips of the branches. The carbon deposits are more prevalent on the samples at higher applied pressures, and generally, channels become darker and more branched over time. Figure 7(a) shows channel characteristics for the samples at 60 kPa, where the channels appear black. Figure 7(b) shows that the tip of the electrical trees consist of carbon deposits. Unlike on the epoxy plaques studied, growth of channels on or in the SiR slab was barely discerned.
