IEEE Transactions on Dielectrics and Electrical Insulation, Vol. 17, Issue 2, pp.
521-532, April 2010

Performance of Silicone Rubber in DC Inclined Plane Tracking Tests

The inclined plane tracking and erosion test IEC-60587 is not specified for DC testing. A dc test has been developed from the current ac standard and three formulations of silicone rubber tested. These materials were tested under three voltage levels (2.3, 2.7 and 3.2 kV) for both polarities. Positive dc tests have the highest average and peak leakage current and exhibit a higher degree of surface damage. The observed surface degradation pattern is heavily dependant on polarity. Consistently higher levels of erosion have been observed in the higher voltage positive cases. Erosion of the surface always starts at the bottom electrode, and spreads toward the top electrode. Puncturing of the 6 mm thick samples or deep erosion over more than half the distance between electrodes has only been observed under 2.7 and 3.2 kV positive polarity tests. Results have been analysed using a variety of leakage current analysis techniques going beyond the criteria specified in the original ac standard. The low-frequency behaviour o

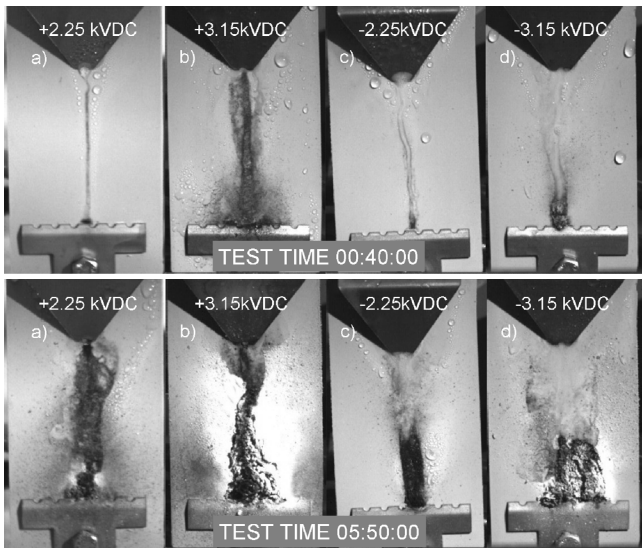
Figure 2 shows the pattern of degradation on typical samples after testing for 40 minutes and almost 6 hours. After 40 minutes all samples show damage due to surface discharges. The damage at 3.15 kV dc is more widespread than the thin line which is developed under 2.25 kV dc. Even at this early stage in a test the patterns of damage under each polarity are different. In positive tests a) and b), a continuous, flat and solid hydrophilic line has formed between the electrodes, whereas in the negative cases c) and d), the track is more predominant in the bottom half of the sample. In -2.25 kV dc tests, a foam forms around the negative electrode tip, which maybe the result of contaminant boiling under Joule heating, but is more likely to be the formation of hydrogen gas as a by-product of electrolysis.

At the end of the test under positive conditions, the solid hydrophilic layer formed between the electrodes is considerably wider than at 40 minutes. However, under negative conditions, this solid layer still only reaches approximately half way up the sample. The charred region which can be seen in both the 3.15 kV dc tests formed from the grounded, bottom electrode and grew upwards and outwards, however, the result is a very different shaped charred region in each case. The principle difference being the extension up to the top electrode in the positive case.

Figure 2. Condition of material A after: top picture 40 minutes and bottom picture 5 hours 50 minutes, where a) +2.25 b) +3.15 c) -2.25 d) -3.15 kVDC tests

take place, for example, decomposition of the ATH or decomposition of the base polymer at higher temperatures. The associated changes in the properties of the material surface may facilitate higher surface currents and so a cycle of increasing degradation evolves. It can be seen from Figure 2b that the maximum current observed throughout the test is considerably higher under positive conditions than it is for negative. This suggests that the potential arc temperature is higher, and we could expect higher levels of damage based on the principle that higher temperatures are being experienced on the sample surface.

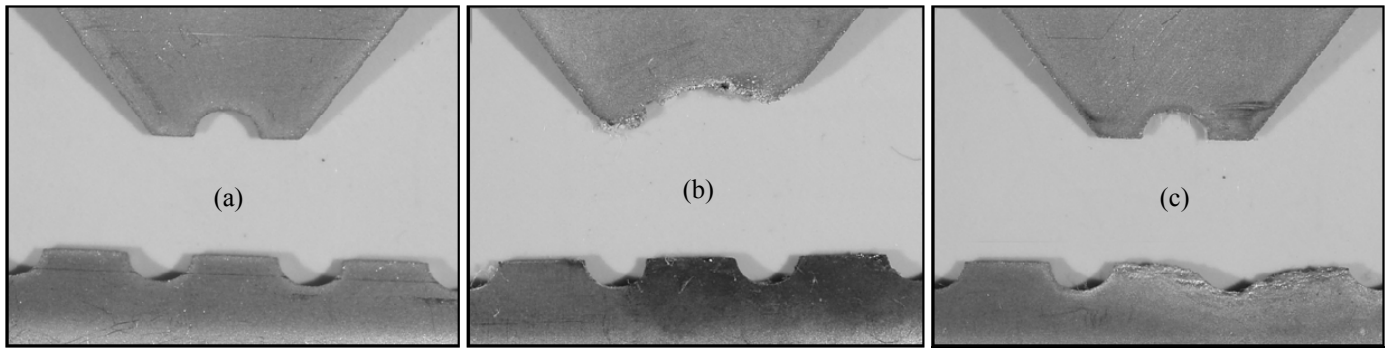
During both ac and dc tracking tests, electrodes can become significantly eroded such that they are unsuitable for use in further tests [10]. For this reason they are only used once. In the dc tests, one electrode erodes significantly more than the other, and the polarity of the dc voltage dictates whether this is the top or bottom electrode. In positive tests, the top positive electrode is more eroded, whereas in negative tests the bottom grounded electrode is more eroded. Figure 4 shows pictures of such electrode erosion after 6 h of testing at 2.7 kV dc. In Figure 4b, there is also a solid dark layer which has built up on the bottom electrode.

Figure 4. Pictures of quill hole of top electrodes (energised) and the middle-section of bottom (grounded) electrodes a) before testing b) after a 6 hour +2.7 kV dc test and c) after a 6 hour -2.7 kV dc test; picture widths are 18 mm

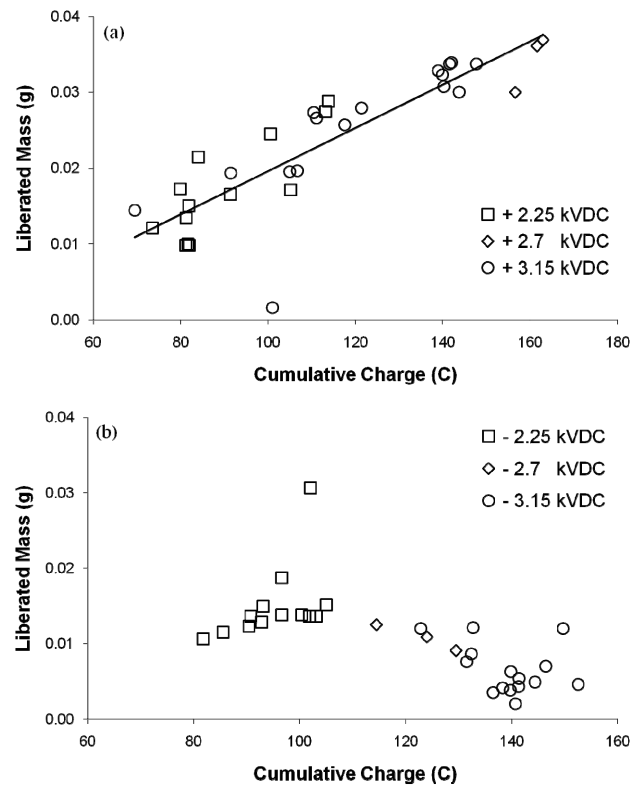
Given that the electrodes used are allowing a current to pass through an ionic solution, it is reasonable to assume the erosion process is due to electrolysis. If electrolysis is taking place, the mass of electrode liberated should be proportional to the total charge passed. In Figure 6a, the trend line shows, this is clearly the case on the top electrode under positive dc.

Figure 6. Cumulative charge versus liberated HV electrode mass for a) top electrode in positive tests and b) bottom electrode in negative tests with all materials shown

locations where deep erosion of the SIR has taken place; this is not seen under -2.25 kV dc. As a result, the trend in Figure 6b does not follow for electrode mass loss under negative conditions on the bottom electrode.

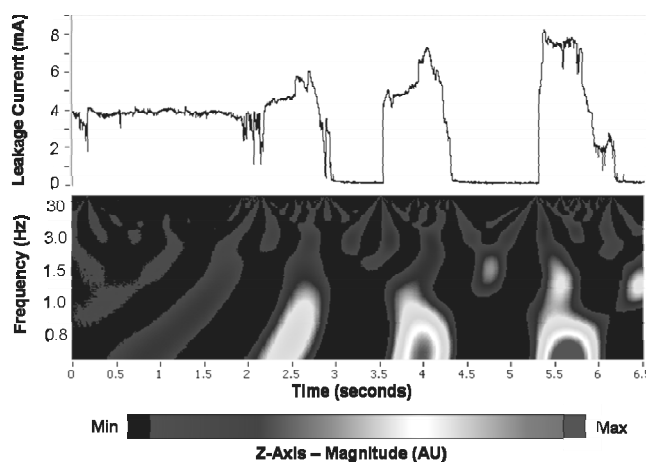
Figure 7. Leakage current signal and wavelet transformed signal for +2.25kVDC test after 20mins on material A

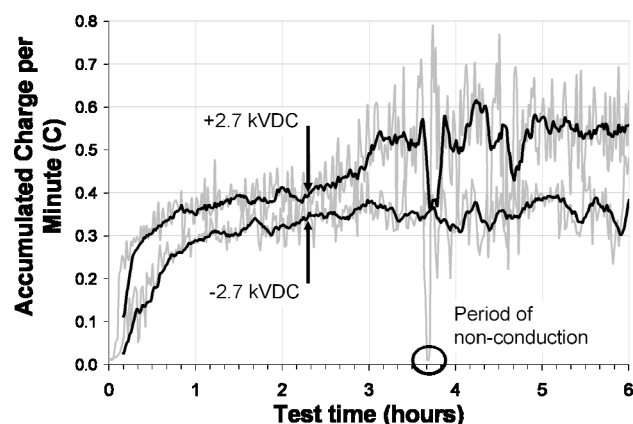
Figure 8 shows that the magnitude of the accumulated charge per minute is higher in the positive case over the duration of the test, despite intermittency being 10% greater than the negative case. This is because positive average current is 2 times greater, and from equation 3 this would be the expected overall effect. In the first hour of the test, accumulated charge per minute increases rapidly, as this is the period when the sample surface is being conditioned by the discharges. By 1 h, the pattern of surface damage looks quite different for each polarity. This raises the question of whether it is the surface degradation which dictates the leakage current, or the leakage current which controls the surface degradation pattern. This is investigated further in section 8.2 where polarity is changed three hours into a test.

Between 1 to 3 h, the accumulated charge per minute increases steadily as the surface becomes more degraded. From 3-6 h under negative conditions there is no significant change in the rate of accumulated charge, however, in the positive case, there is a transition at the three hour point where the rate increases by 0.1 C/minute. This occurs at the onset of deep erosion in the test, where the formation of char on the surface allows a larger volume of contaminant to be retained at any one time. The result is often higher peak currents and more damaging discharges. The char on

the surface can also change the path in which the contaminant flows, which may cause periods of non-conduction as happens at 3 hour 40 minutes in the positive test shown.

Figure 8. Moving average of 10 of accumulated charge per minute for material C in a positive and negative polarity 2.7 kV dc test

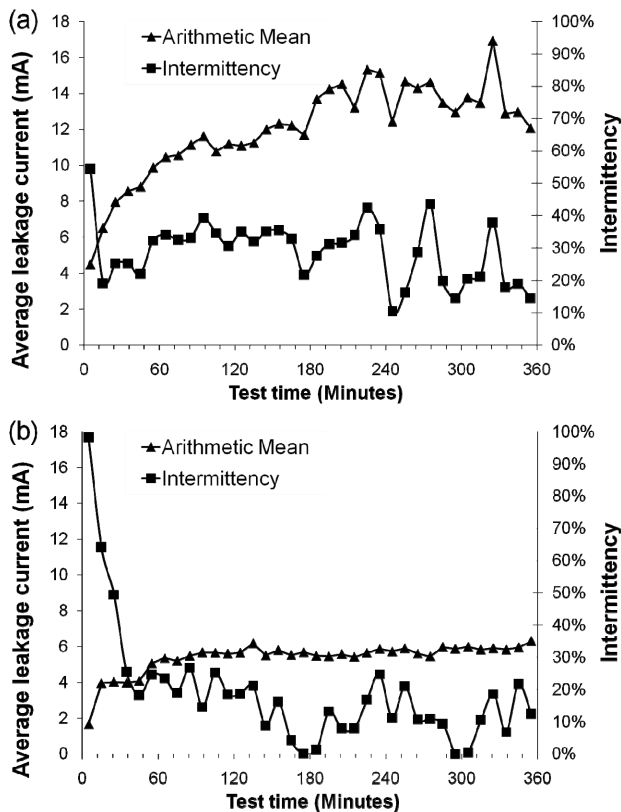
As in the accumulated charge plot, Figure 9a shows a rise in average leakage current at 3 h (180 minutes) in the +2.7 kV test. After the onset of deep erosion, the intermittency begins to vary as the sample alternates between non conductive and highly conductive states. After 5 hours 20 minutes (320 minutes) there is a 2 milliamp rise in average current and a 20% increase in intermittency. Observed video images at this time, does not show if this particular condition gave any increased rate of damage. Because the increase in current was met by an increase in intermittency, the accumulated charge for this period remains fairly constant. In the -2.7 kV dc test, the average current is smaller in magnitude, but is also remarkably stable over the course of the test. The intermittency is also lower than the positive case, and there are a number of

Figure 9. Intermittency (%) and average current (mA) in 10 minute intervals for (a) +2.7kVDC (b) -2.7kV dc on material C.

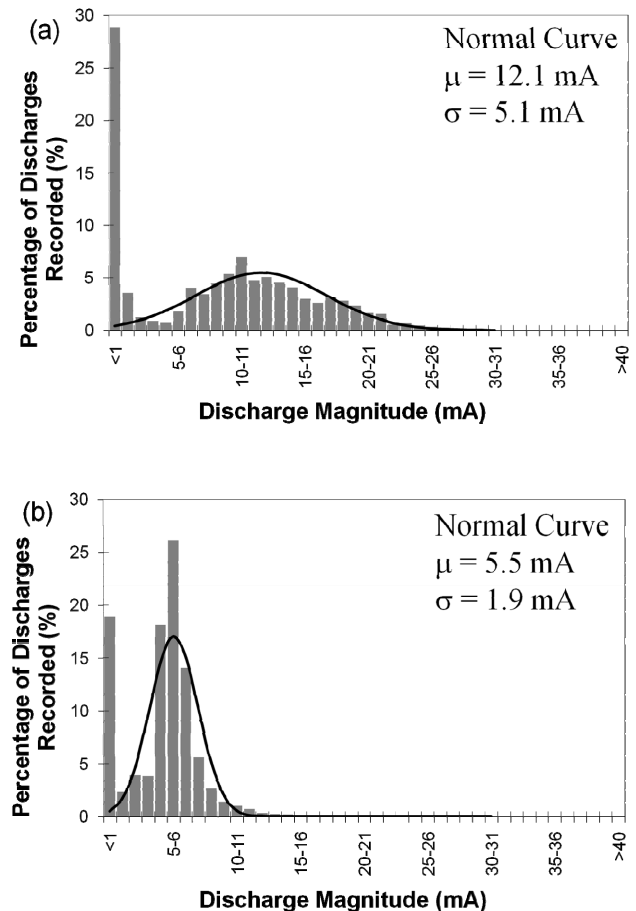
The leakage current distribution has been analysed by sampling the current magnitude at a rate of 15 samples per second and plotting the information in a histogram with a bin range of 1mA. In

Figure 10, the first column (<1mA) shows the percentage of recorded discharges where the sample surface was non-conducting; this is the measure of intermittency. When the sample is conducting, the distribution of leakage current magnitude follows a normal distribution. It is envisaged that the current follows a normal distribution because there are a large number of factors which contribute to its overall nature.

Figure 10. Histogram of leakage current magnitude for (a) +2.7 kV, and (b) -2.7 kV on material C. Best fit normal distributions are shown and mean (μ) and standard deviation given (σ)

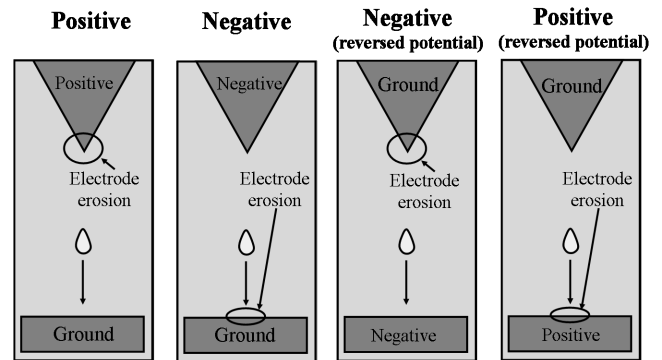
In the following 'reversed potential' tests, the bottom electrode is energised and the top electrode is grounded as depicted in Figure 12. The effect of this is that the potential across the sample is opposite polarity and equivalent to the standard opposite polarity test, however, the potential with respect to external objects is changed. Results are presented from single 2.7 kV dc tests on material A.

Figure 12. Electrode reversal configurations. The two cases on the left are traditional with grounded bottom electrodes, in the reversed cases on the right the upper electrodes are grounded.

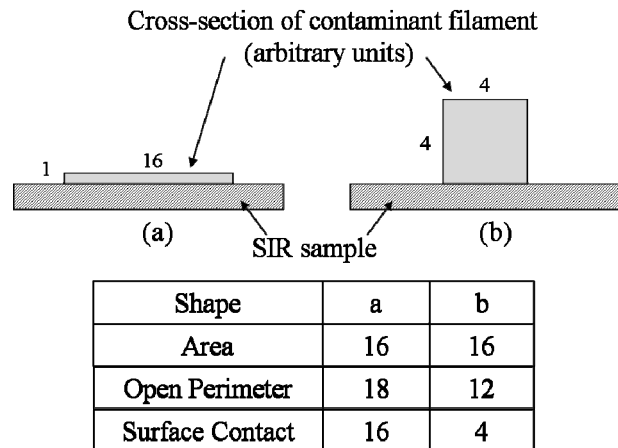
Figure 16. Contaminant cross-sectional area.

The shape which the contaminant takes on the surface of the SIR will change the evaporation rate. This means that the surface condition of the material is very important. The difference in the shape and extent of the aged surface is very different in the positive and negative cases, and may be the fundamental difference controlling the disparity of results in the two situations. Consider two different shapes of contaminant cross-section on the dielectric surface, which are of the same cross-sectional area: In case A, the perimeter which is open to the air and that can be evaporated is greater than case B. The situations could be compared to a hydrophobic and hydrophilic surface in the case of SIR, where case A is hydrophilic. This could potentially increase the evaporation rate, if there is sufficient heat being generated to maintain the contaminant temperature. Similarly case A has greater contact area with the solid surface and may be cooled by the thermal mass of the solid. Conversely, the bulky filament will be cooled less per unit volume by the air and the solid surface, and so may reach higher temperatures, and hence evaporate quicker. Each cross-sectional area may also influence arc longevity, and arc-root localisation. Further analysis is required to understand the thermodynamics of the two cases.
