DOI:  
[10.1109/CEIDP50766.2021.9705475](https://doi.org/10.1109/CEIDP50766.2021.9705475)

# Negative DC Breakdown Characteristics of C<sub>3</sub>F<sub>7</sub>CN and CO<sub>2</sub> Mixture with Different Electrode Materials

F. O. Bahdad, L. Chen\* and S. M. Rowland  
School of Electrical and Electronic Engineering  
The University of Manchester  
Manchester M13 9PL, UK  
[\\*lujia.chen@manchester.ac.uk](mailto:*lujia.chen@manchester.ac.uk)

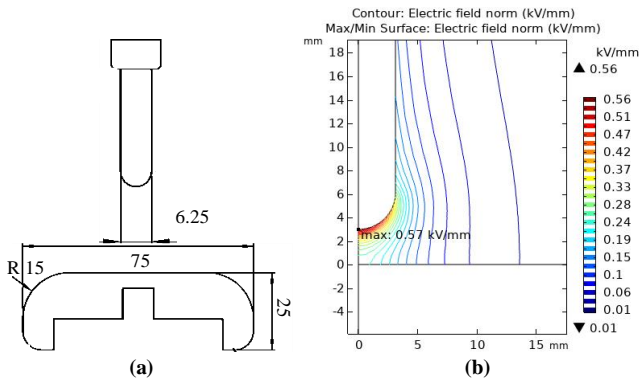
Figure 1(a) shows the dimensions and Figure 1(b) illustrates the  $E_{max}$  simulation of the test configuration with a calculated  $f$  of 0.59.

**Figure 1.** (a) Rod-plane test configuration with dimensions in mm and (b) electric field simulation for a 3 mm gap and 1 kV applied voltage.

A rod-plane configuration with a fixed gap of 3 mm was used to represent a quasi-uniform field commonly found in gas-insulated equipment. COMSOL version 5.3 was used to simulate the maximum electric field ( $E_{max}$ ) and the field utilization factor,  $f$  was calculated by the ratio between the mean electric field ( $E_{mean}$ ) to the  $E_{max}$ .

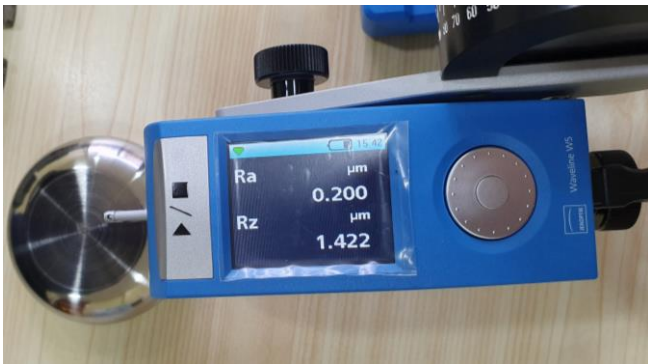
Before measuring the surface roughness, the accuracy of the measuring probe was checked against a calibration set (a pre-determined surface roughness block) to ensure the accuracy of the subsequent measurement. Figure 2 shows a photographic example of surface roughness measurement.

**Figure 2.** Surface roughness measurement of a polished electrode surface.

All fabricated electrodes were polished to a mirror surface finish with an average surface roughness ( $R_a$ ) of 0.2  $\mu\text{m}$  and a maximum surface roughness ( $R_z$ ) of less than 2  $\mu\text{m}$ . Jenoptik wave line W5 was used to measure  $R_a$  and  $R_z$  values before and after the testing. All measurements were obtained from the middle of the rod-plane electrode where most of the discharges occur.

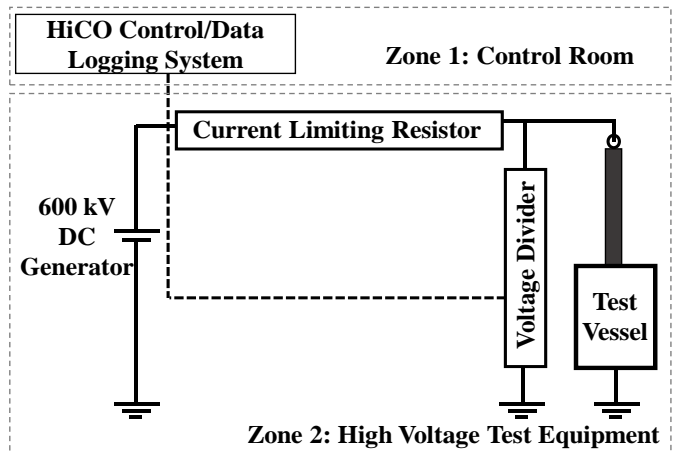
Figure 3 shows the test circuit for DC breakdowns. The DC test generator is rated at 600 kV and 200 mA with a ripple factor of less than 3%. Breakdown voltage is measured by a resistive voltage divider that is connected to a data logging system via a fiber optic cable. Successive discharge procedure was followed in accordance to BS EN 60060-1:2010 [14]. A 5 kV/s voltage ramp rate is applied until the breakdown has occurred. The time interval between a breakdown and the next voltage ramp was set at 2 minutes. An average value of breakdowns was used to determine the probability of the 50% breakdown voltage ( $U_{50}$ ) value.

**Figure 3.** Schematic diagram of the DC breakdown experiment.

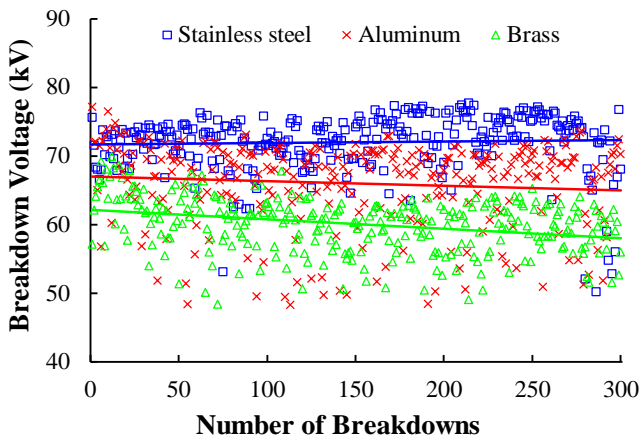
Figure 4 shows the breakdown result of 300 negative DC breakdown for the tested electrode materials under 4.8 bar.

Results in Figure 4 demonstrate that stainless steel has higher breakdown voltage than aluminum and brass electrodes.

Figure 4. Negative DC breakdown characteristic of 20%  $C_3F_7CN$  / 80%  $CO_2$  mixture tested using a rod-plane configuration (rod dia. of 6.25 mm), for stainless steel, aluminum and brass, a fixed gap of 3 mm and a pressure of 4.8 bar. The straight lines represent best fit in each case.

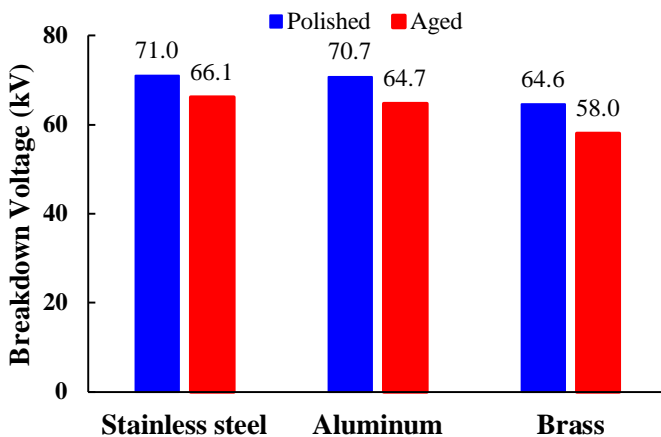
Figure 5 presents the average voltage of the first and last 20 breakdowns. As shown in Figure 5, the average voltage of the first 20 breakdowns for both aluminum and stainless steel were comparable with brass being the lowest. This is mainly due to the difference in work function of the electrode materials as it is the minimum energy required to de-attach an electron from a solid surface. Therefore, an electrode material with high work function will attain a higher breakdown voltage [8].

Figure 5. First and last 20 breakdowns averaged from the 300 breakdowns for 20%  $C_3F_7CN$  / 80%  $CO_2$  using stainless steel, aluminum, and brass electrodes.

The work function of aluminum is close to the stainless steel one as shown in Table 1. As a result, a comparable breakdown voltage might be expected for the polished electrodes.

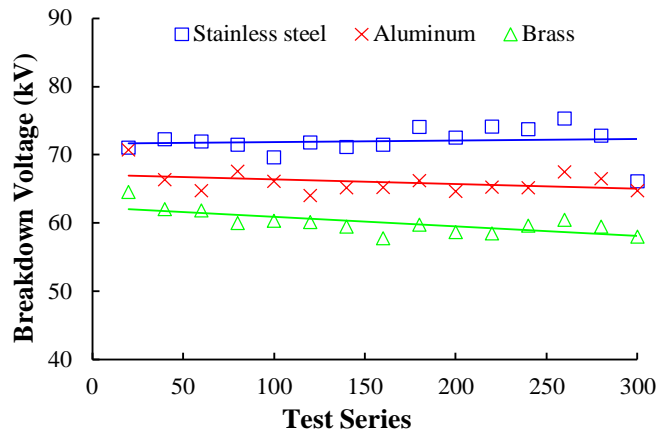
In Figure 6, breakdown results were depicted as calculated average of every 20 breakdowns. A gradual declining data trend can be observed for both aluminum and brass test configurations, whereas the breakdown voltage of stainless steel configuration remained relatively consistent until the final 20 breakdowns.

Figure 6. Average values from every 20 breakdowns for aging experiments of 20%  $C_3F_7CN$  / 80%  $CO_2$  tested using stainless steel, aluminum and brass electrodes.

The declining trend observed in the breakdown voltage shown in Figure 6 is mainly caused by the accumulated surface damage on the tested electrodes. It was reported in [7] that rougher electrode surface has a negative effect on the DC breakdown characteristics of C<sub>3</sub>F<sub>7</sub>CN / CO<sub>2</sub> gas mixture. Table 3 depicts the measured R<sub>a</sub> and R<sub>z</sub> pre- and post-aging experiment for all three electrode materials.

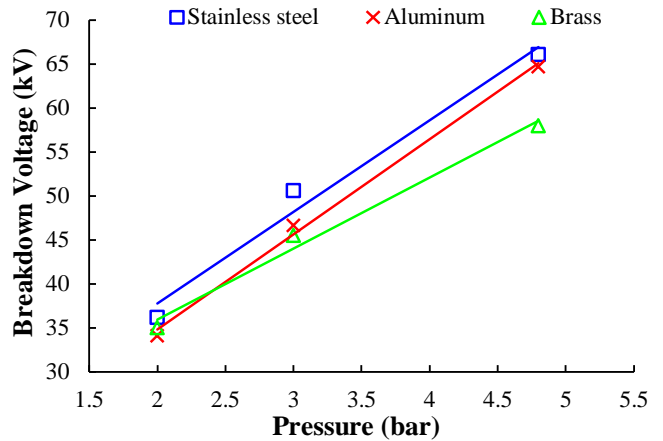
Further investigation was carried on the effect of pressure on the aged electrodes from the first set of experiments, Figure 7 shows the results for 4.8, 3 and 2 bar for all three electrode materials.

Figure 7. Negative DC breakdown for 20%  $C_3F_7CN$  / 80%  $CO_2$  tested using a rod-plane configuration (rod dia. of 6.25 mm), for stainless steel, aluminum and brass, a fixed gap of 3 mm and a pressure of 4.8, 3 and 2 bar.

In [7], it was reported that the effect of electrode surface roughness on the DC breakdown voltage of  $C_3F_7CN$  /  $CO_2$  gas mixture is influenced by the gas pressure where the effect of surface roughness is more profound at higher pressures. As shown in Figure 7, all materials show comparable breakdown voltages under 2 bar with greater difference observed for 4.8 bar results. This is in agreement with conclusions in [5]. It also suggested that the effect of electrode surface roughness and material on the breakdown voltage are affected by the gas pressure where the effect will be more significant under higher pressures.
