Engineering a solution to the problem of dry-band arcing on ADSS cables

IEEE Electrical Insulation Magazine 22 Issue 4 (2006) 34 - 43

S M Rowland

**ENGINEERING A SOLUTION TO THE AGEING OF HV SELF SUPPORTING CABLES
BY DRY-BAND ARCING**

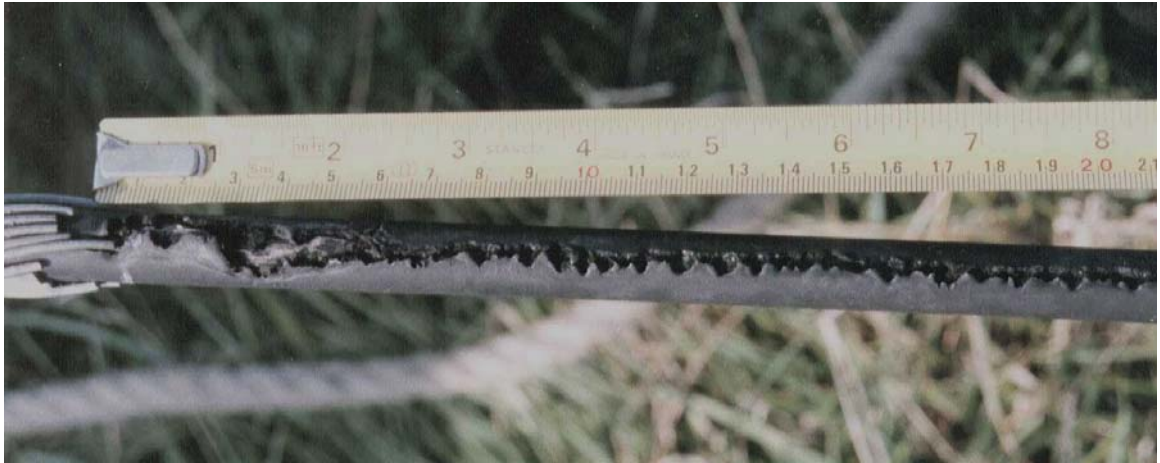
Figure 3. A photograph of cable damaged on a 400 kV line. The deep trough in the sheath is visible on the underside of the cable. The metallic wires on the left of the picture are part of the clamping system.

The presence of arcs will damage traditional cable sheath materials. Arcing results in carbon tracks forming (for example with PVC), oblation of material (for filled EVA) or simple melting processes (for polyethylene). Which ageing mechanism tends to dominate depends upon the intensity of the arcing and the material concerned. Improvements have been made to the cable surface by producing improved polymeric compounds [8,11-13]. These materials have significantly enhanced the life expectancy of cables. Unfortunately ageing processes are not yet well enough understood to enable clear lifetime predictions to be made [14-16]. Nonetheless, cable manufacturers have sufficient confidence in their products to offer them into various situations. Virtually all manufacturers will offer cables onto 150 kV lines and below. Figures 3 and 4 show pictures of damage from installations on 400 kV and 110 kV lines respectively.

To confirm the theoretical models and computer simulations, extensive trials were carried out at a location where the phenomenon of dry-band arcing was previously reliably produced (figure 3). This provided a situation where the damage to an unprotected cable could be reasonably predicted. Two 400 kV spans with high levels of salt fog were utilized. A high level of instrumentation was used to measure high and low frequency current on the cable. Also recordings of weather were also taken [20,24]. Figure 12 shows measurements made on an ADSS cable. The measured currents were very close to those predicted by the computation model used. Of particular interest are the periods of high current detected when single circuits were switched out, as seen repeatedly in May and again in July. In these periods the currents increase as phase cancellation from the two circuits no longer occurs (as shown in Figures 5 and 7). Also the base line currents are higher in June and July when rainfall is least. This is explained by an accumulation of salt on the cable during periods when there was no rain to wash it off, but fog was frequent. Towards the end of July rain cleans the cable and the current is reduced. Figure 13 shows measurements of currents which reveal arc activity on a cable. Adjacent spans were compared with and without rods attached. A continuous current of 1 mA is seen to be drawn by the rod. On the cable with no rod, significant 50 Hz and high-frequency currents can be seen at times of high humidity, indicating arcing activity. This period of time was one of unusually high activity. Regular inspections of the cable surface were carried out to correlate the condition of the cable with periods of arc activity.

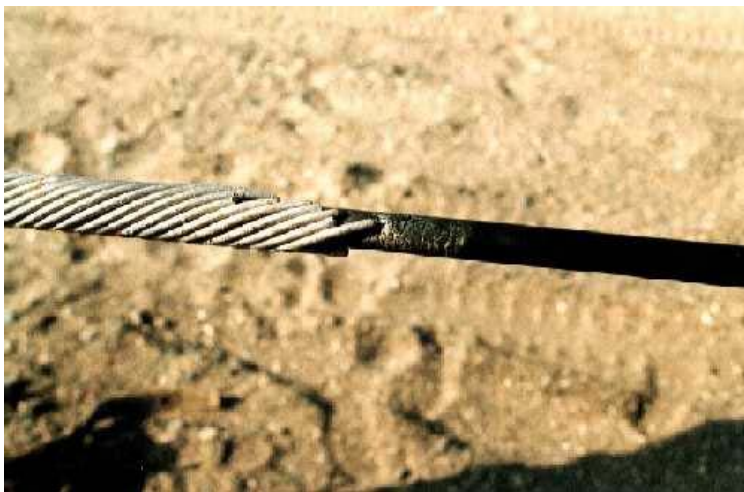
Figure 4. Damage on a polyethylene sheathed cable on a 110 kV line. The metallic wires on the left are part of the cable clamping system at the tower.

One utility which installed a long route of polyethylene-sheathed ADSS cable, supplied by a number of companies, discovered damage associated with dry-band activity after only 6 months' installation (Figure 4). The original ADSS cable had been installed with a calculated background space potential of less than 12kV RMS for each tower type. This is below the safe installation limits described in specification IEEE P1222 [23]. However this cable is located in an area of very low rainfall and high levels of salt (from the sea) and industrial pollution. Lines of 110 kV and 220 kV system voltage are being used and both experienced problems of cable damage.

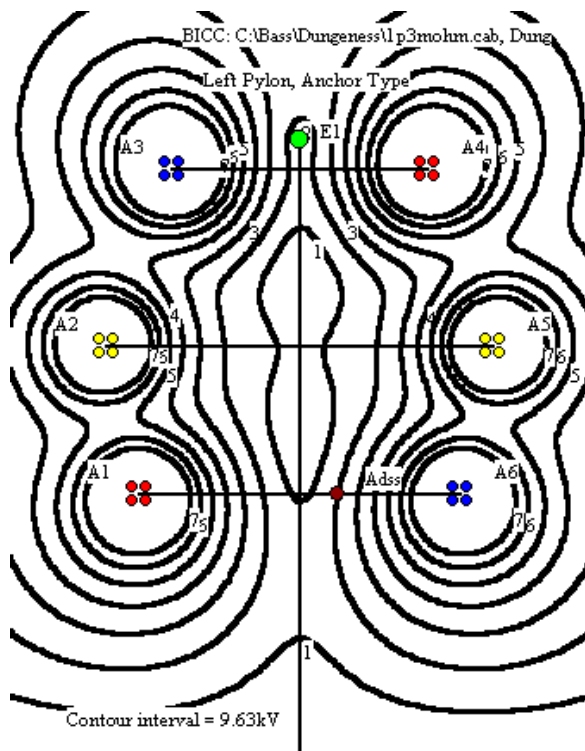
Figure 5. Space potential plots on a mid-span plane perpendicular to the conductors on a 400kV line. The contour intervals are 9.6 kV. Each contour is marked by the number by which 9.6 kV is to be multiplied to determine the space potential. The phase arrangement is ABC, CBA.

The use of mid-span equipotential contours such as that shown in Figure 5 has become standard practice. In an ADSS application analysis, the space potential contour plot is studied in order to identify locations of low space potential, where the ADSS cable could be installed. Historically, a space potential contour of 12 kV and above was considered to represent locations within which an ADSS cable could become susceptible to damage by dry-band arcing [23]. Guidelines relating to the geographical location of the proposed ADSS installation were also created in an attempt to ensure that the currents on the cable were acceptably low. For example, Table 1, reproduced from Carter et al [24], shows a proposed estimation technique for relating the 'safe' space potential threshold level to the estimated resistance per unit length of the cable; above the threshold level, damaging arcing may reasonably be expected to occur.

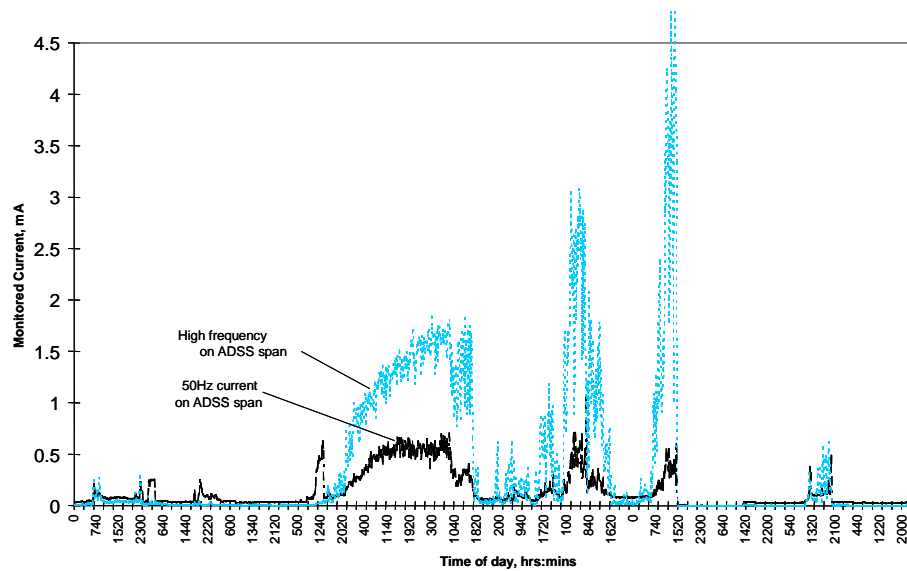
Figure 6. Measurements of current on an ADSS cable, on 400 kV line in polluted conditions. The lower levels of current represent the 50 Hz component and the dashed line shows higher frequency components implying periods of arc activity.

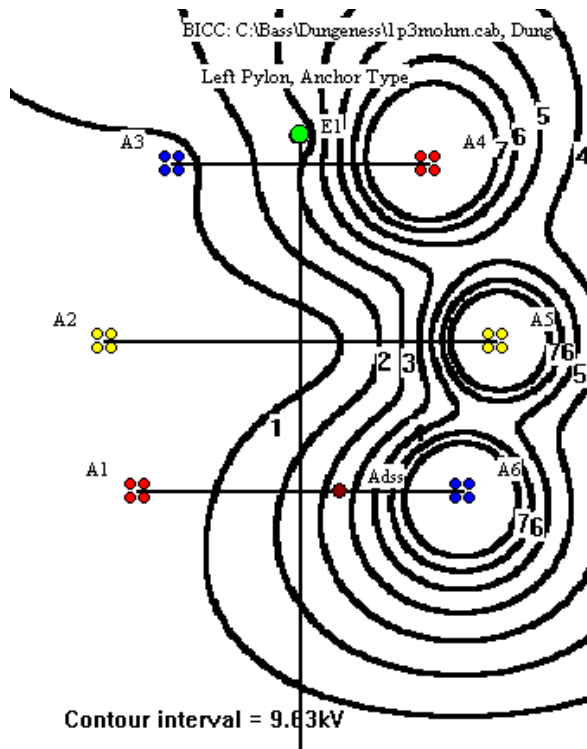
Figure 7. Space potential plot on a mid-span plane, perpendicular to the conductors for the span shown in Figure 5 with a single circuit outage. The contour intervals are 9.6 kV.

Such analysis of space potential contours must however be complete. It is necessary to consider the effect of single circuit outages on twin circuit lines. Figure 7 shows that in such circumstances calculated potentials can rise significantly, as will associated currents. This is important because even if such outages last for a small fraction of time, it has been shown that aggressive ageing tends to occur in short periods, not gradually over the cable's life. Thus such outages combined with high pollution levels might combine to provide conditions necessary for severe arcing to take place.

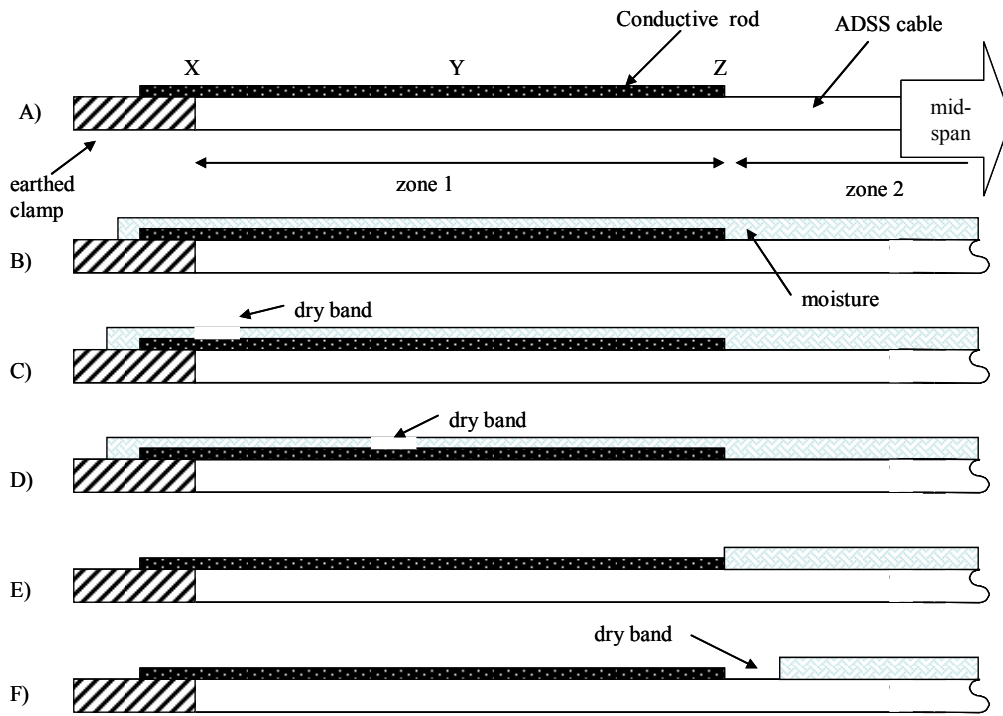
Figure 11. Schematic showing the different conditions experienced by the system.

The maximum current seen in the whole system will generally be at the clamp, and this is shared between the rod and the cable surface. Each of the drawings in Figure 11 illustrates a different situation to be considered in the design. Here the cable is represented as a substrate for conductive pollution. We define zone 1 as that part of a half-span covered by the rod, and zone 2 as that region beyond the rod end to mid-span. For clarity, the clips are not shown in this diagram.

Figure 11(A) shows a dry cable with a resistive rod. The maximum current in this system at X is the current accumulated over zone 1, as shown in Figure 9. This is the minimum current ($i_{x \text{ dry}}$) which the resistive rod will experience and must be endured over its lifetime. Joule heating is given by $(i_{x \text{ dry}})^2 R_r$, where R_r is the resistance per unit length of the rod. This heating is continuously generated and must not age the rod unacceptably. The limiting value depends upon the rod design. In the design considered we require:

Figure 11(B) shows the situation when the cable is completely wet. The current is greater than in case 11(A). The current at X, $i_{x \text{ wet}}$, will be shared between the rod and the moisture. Dry band formation will be slowed by the presence of the rod since the normal positive feedback effect of increasing resistance as moisture is dried will be reduced.

Figure 11(C) shows a dry band formed at the clamp end of the rod at X. The voltage gradient on the rod is increased across the dry band. This is because the current is virtually unaffected by the local increase in resistance. If the voltage across the dry band is sufficient, an arc will occur. The voltage available for an arc across the dry band is given by the product of $i_{x \text{ wet}}$, R_r and the dry band width. To ensure an arc cannot strike we require that:

Figure 11(D) shows a dry band within the length of the rod, at Y. If R_r is well controlled and constant along the rod length, this situation must be less onerous than at a dry band at X, since the current must be lower. In real systems, local variations in R_r must be expected, and the key to manufacturing such a rod is ensuring this variation is within acceptable limits so that Joule heating is tolerable, and the voltage across such gaps is controlled satisfactorily.

The case shown in Figure 11(E) is similar to that in (A). The primary difference is that a current, i_z , can now flow through the tip of the rod from the rest of the span at point Z. Therefore, the current at X will also increase.

Figure 11(F) shows the condition which is most likely to give rise to dry-band arcing if the system is poorly designed. This was experienced during product development. For example, if zone 1 is very conductive (i.e. if R_r tends to metallic levels), the situation is unchanged from that of a wholly dielectric system; it is simply as if the clamp has been shifted up the cable. The parameter determining whether or not a damaging arc can form is the current, $i_{z \text{ wet}}$, available if no gap were present, as in the case of Figure 11(E). If $i_{z \text{ wet}}$ is kept sufficiently low any arc activity will not be severe enough to damage the cable, and so in this case we require:

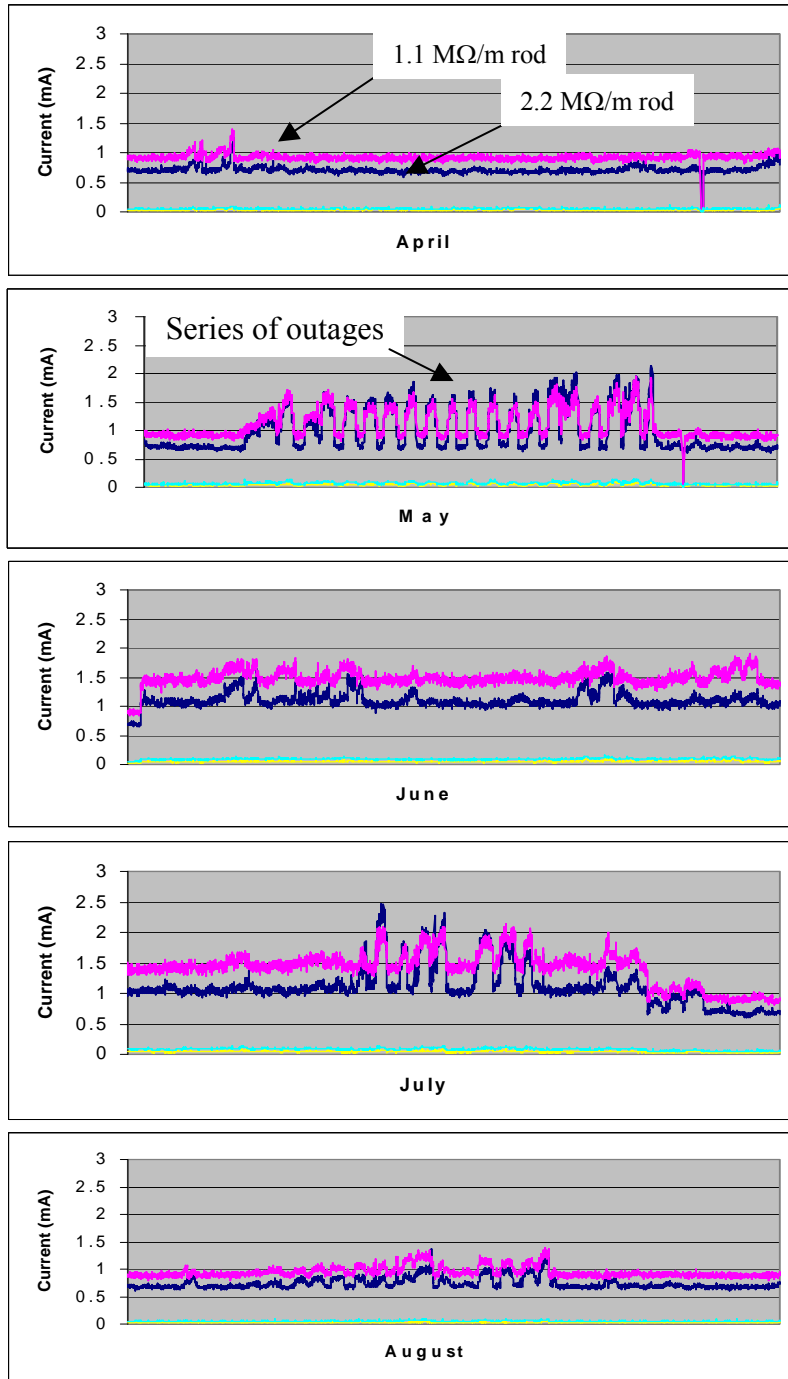
Figure 12. In each the case the graphs contain two traces from a 400 kV line. The higher trace represents the current measured on a 1.1 M Ω /m rod and the lower current represents the current measured on a 2.2 M Ω /m rod.

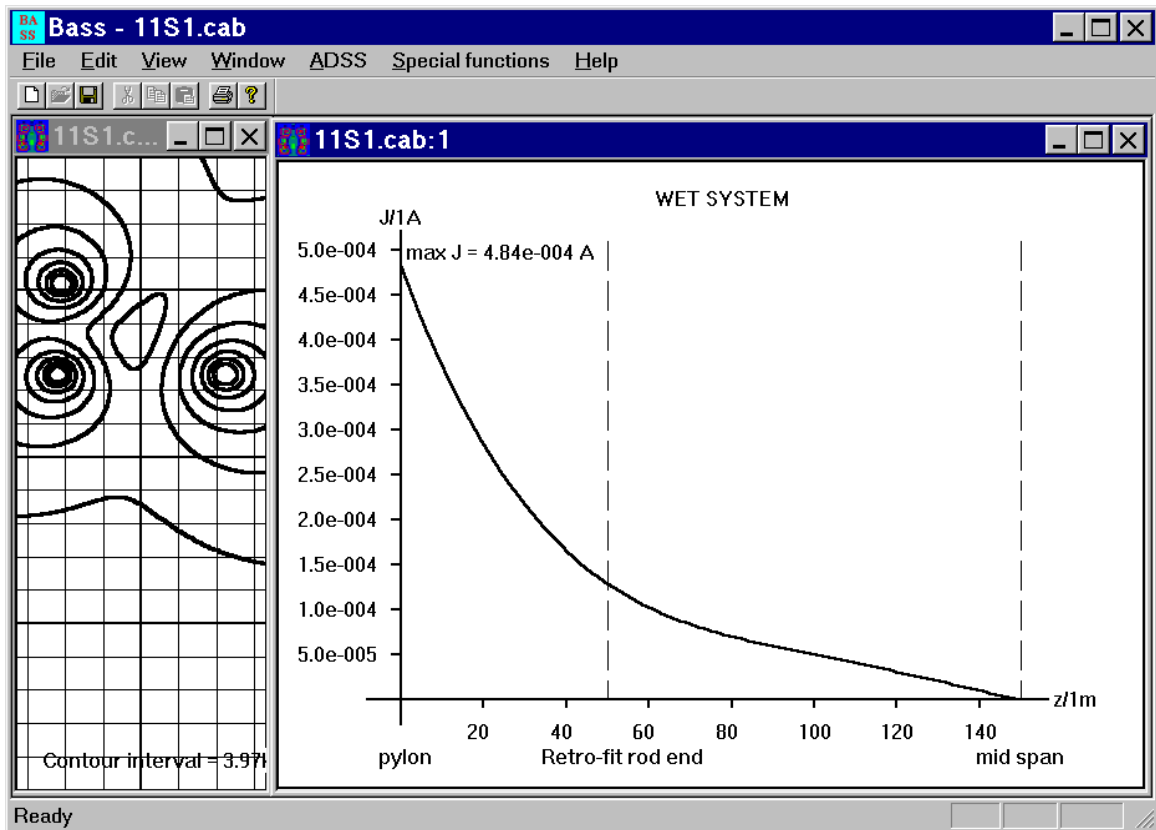
Figure 14. Predictions of space potential at mid-span, and current along the length of a half-span for a 110 kV single circuit line. The contours are multiples of 4 kV. The maximum current at the tower is 0.48 mA, and the current at the 50 m long rod tip is 0.12 mA.
