# Lamb Waves Boundary Reflections in an Aluminium Plate for Defect Detection related to Structural Health Monitoring.

Muller, A., Robertson Welsh, B., Gaydecki, P., Gresil, M., & Soutis, C. (2016). *Lamb Waves Boundary Reflections in an Aluminium Plate for Defect Detection related to Structural Health Monitoring.*. Paper presented at 8th European Workshop On Structural Health Monitoring (EWSHM 2016), Bilbao, Spain.

## Lamb Waves Boundary Reflections in an Aluminium Plate for Defect Detection related to Structural Health Monitoring.

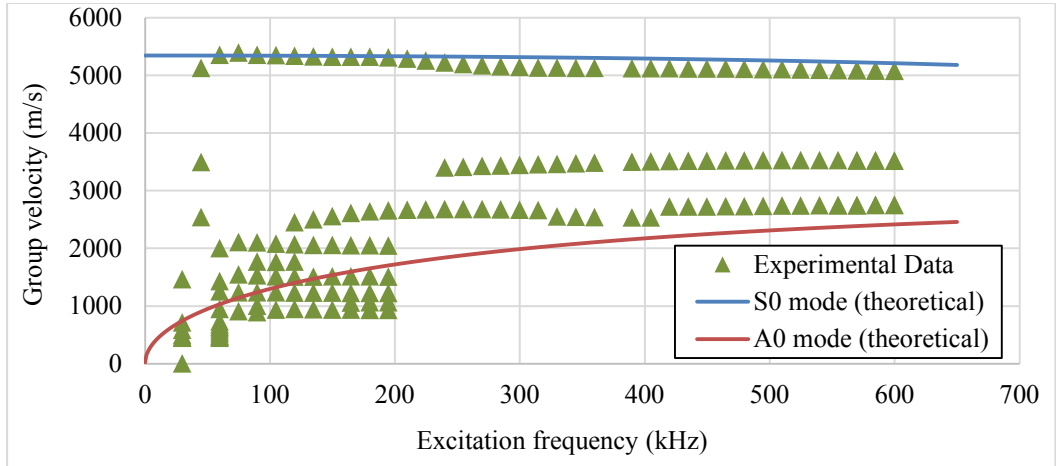
Figure 2: Dispersion curves of the aluminium plate.

A series of response signals were obtained by varying the frequency of the excitation signal from 30 kHz to 600 kHz. The resulting dispersion and tuning curves are shown in Figure 2 and Figure 3. The procedure to obtain the experimental dispersion and tuning curve can be described as follows: (1) the Hilbert transform of the input and output signal was derived; (2) a low pass filter was implemented to smooth the data; (3) the time of flight was calculated by subtracting the time of the maximum amplitude of the received signal from the time of the maximum amplitude of the transmitted signal; (4) The group velocity was then obtained by dividing the distance between the sensors (40 cm) with the time of flight.

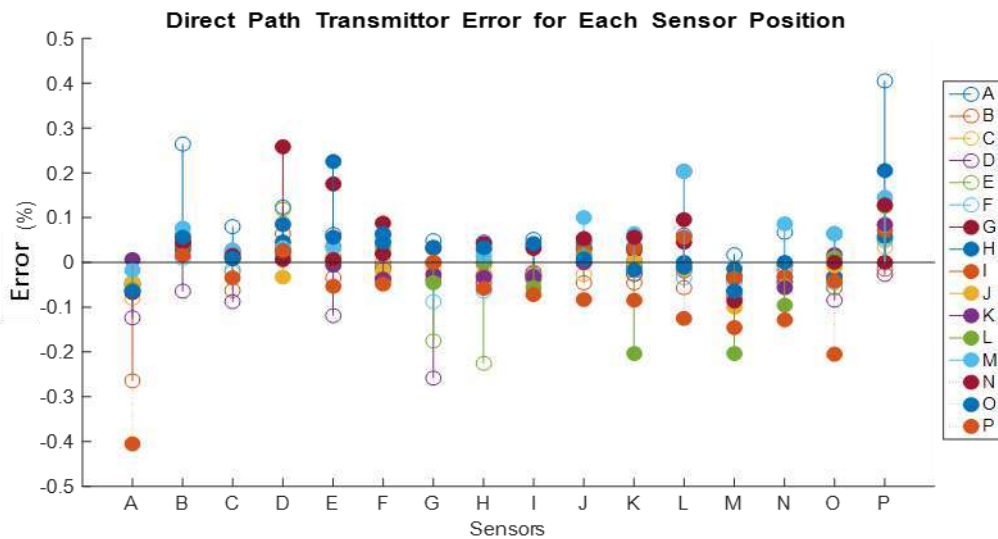
Figure 5: Direct path transmitter percentage error distribution for each sensor position.

The percentage error between the transducers is plotted in Figure 5. Note that the absence of any clear pattern, which would indicate a systematic error, in addition to the low magnitude (maximum error is below 0.5%) verify the validity of the experimental results. The error distribution presented is assumed to be randomly distributed, and within acceptable limits.

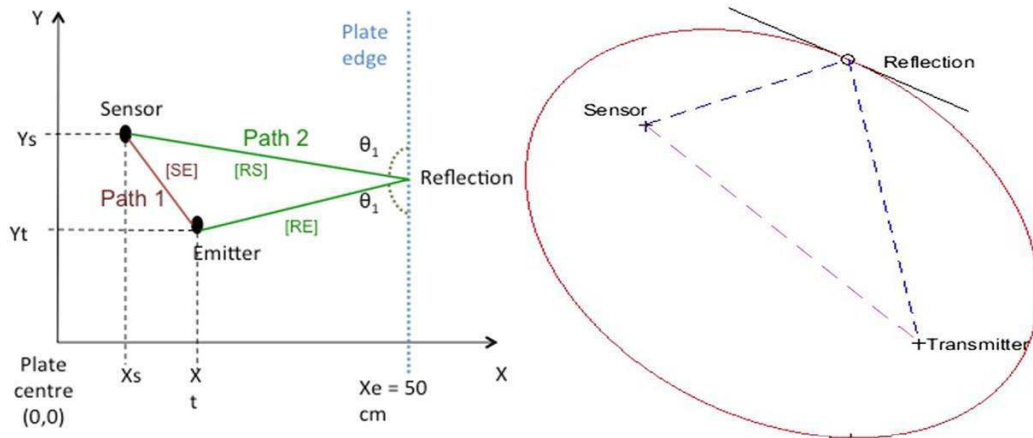
Figure 6: Example of the direct path (path 1) and first reflected path (path 2) from the closest edge (left) and an example of an ellipse with the possible location of the closest edge (in red) (right).

The position of the plate boundaries relative to the transducers was determined using the time of flight of the second wave packet, which is assumed to be a single reflection from an edge. It was assumed (based on previous literature [9]) that when S0 mode hit the free edge of the plate it was reflected with the same angle, and at the same speed, as the incident waves. Whilst past literature has shown this is not always the case, such a solution can provide the position and angle of the edge with respect to the transmitter and receiver. In combining multiple, separate transmitter/receiver signals, it is possible to construct edge boundaries using only the predicted reflections which are in agreement, and ignoring isolated solutions. Following this assumption, all possible solutions representing where the reflection could occur can be described by an ellipse (assuming only one reflection occurred on the wave's path). The two foci of this ellipse are the emitter and receiver transducers, the time of flight for the first wave packet represents the distance between the two foci (Path 1 in Figure 6), and the reflected distance is represented by the time of flight for the reflected wave packet (Path 2 in Figure 6). The tangent to the ellipse at any point represents the edge angle necessary for a specular reflection at that point.

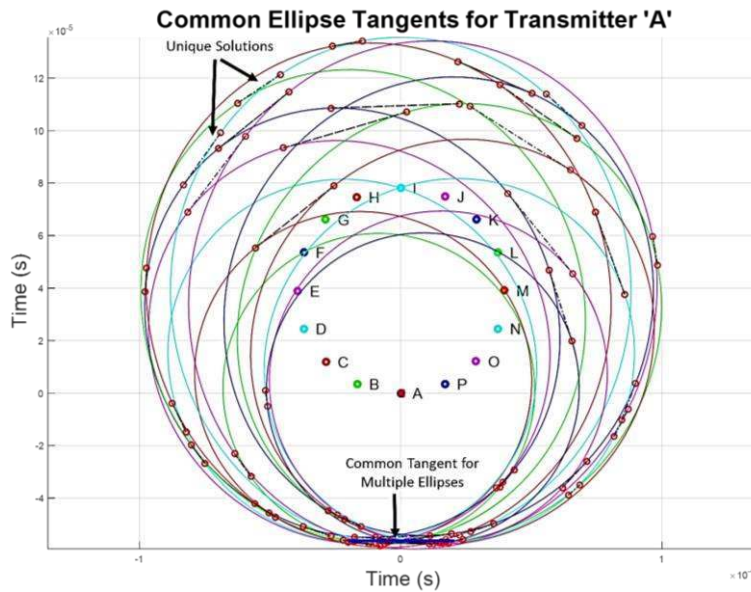
Figure 7: Representation of the detection of the edge location using common ellipse solution (in the time domain).

Two ellipses, constructed from two different transducer combinations, would have two common tangents. These common tangents represent an isolated solution. Where more ellipses also share a common tangent with the first two ellipses, the common tangent is considered to be the plate boundary. An example of this is shown in Figure 7, where all isolated solutions are shown as black, dotted lines, and the plate boundary, shared by more than two ellipses is shown as a blue line. In this example, only the reflections produced when the transducer 'A' acts as the transmitter are considered. It is also worth noting that Figure 7 is plotted in the time domain and the triangulated locations of all other transducers are also plotted (with 'A' as the reference).

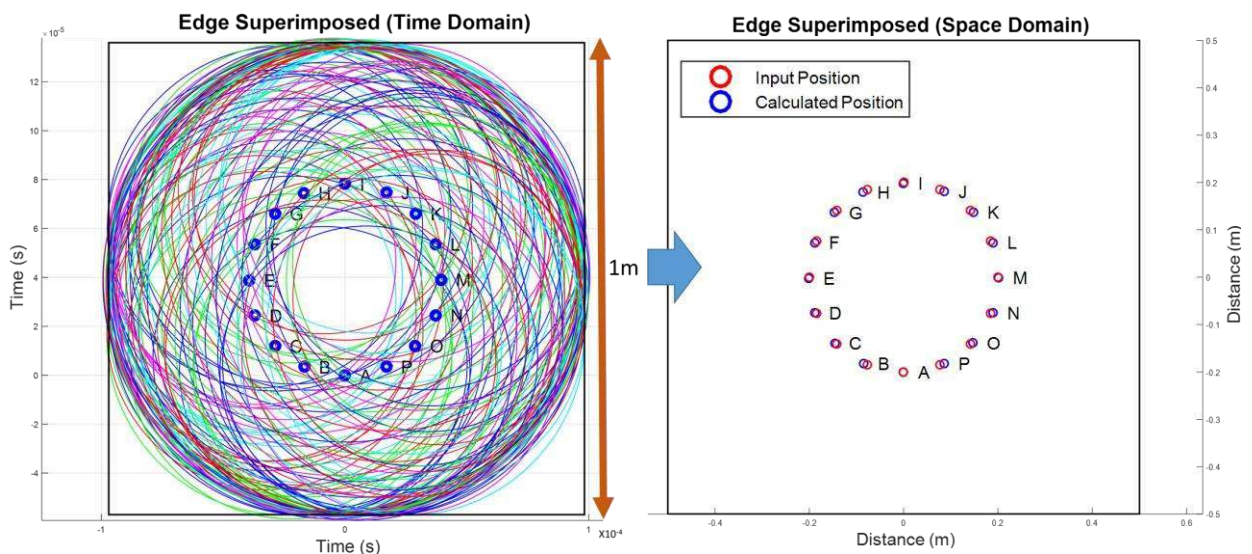
Figure 8: Representation in the time domain of all ellipses derived from the 240 baseline signal (right) and comparison between the input (or measured) sensors position with the position calculated with the post processing of the signal.

Applying this method to all transducer combinations produces the ellipses shown in Figure 8. From this, four clear boundaries are observed. Applying the knowledge that the plate is a 1m x 1m square enables the coordinate conversion from the time domain to the space domain. Figure ojiopj shows the calculated transducer position in the space domain (blue) compared to the assumed transducer position (red).

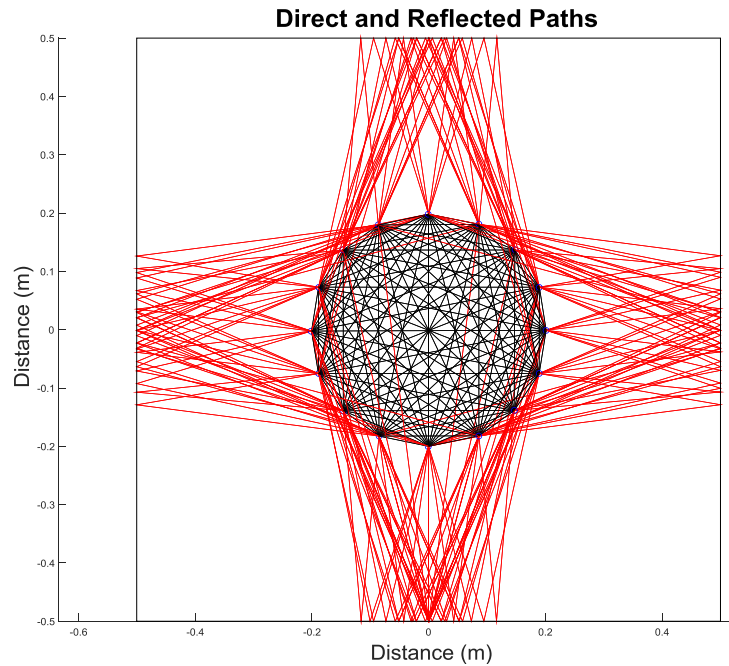
Figure 9: Representation in the special domain of the direct wave's paths (in black) and the reflected wave's paths validated with common tangents (in red).

The wave speed of  $5121.1 \text{ m.s}^{-1}$  compares favourably with the wave speed calculated from the S0 mode tuning curve in Figure 3. As a consequence of this, the assumed path of the reflected wave packets can be considered accurate for the transducer combinations which share multiple common tangents. These wave paths are shown in Figure 9 (in red), alongside the direct paths (in black). This represents a significant extension to the area of inspection.

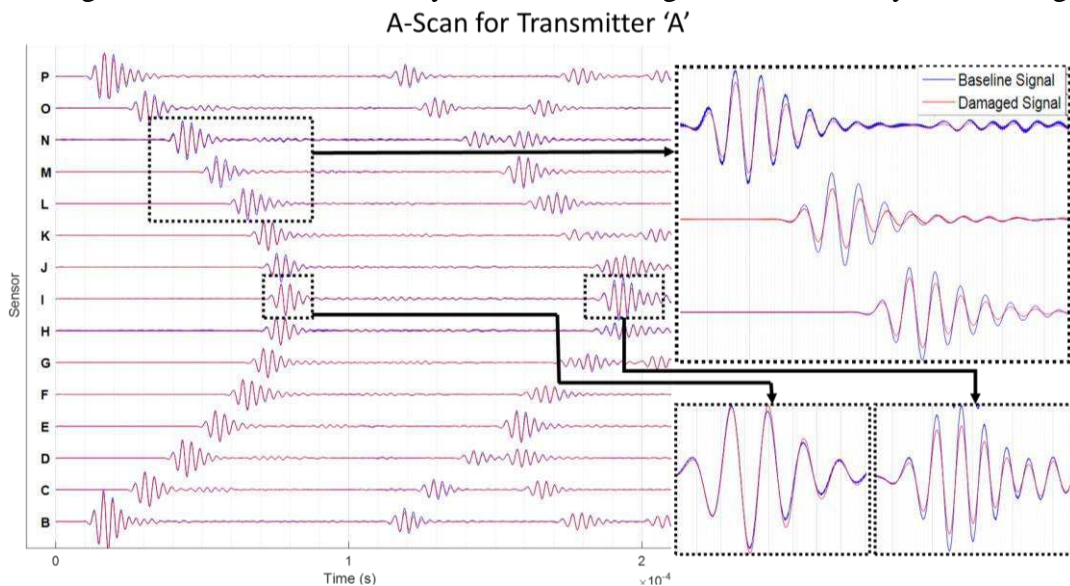
Figure 11: A-scans results obtained for the baseline signal, and after the implementation two coupling defects, when transducer 'A' is transmitting.

For Test 2, simulated damage was applied as in Figure 1. Figure 11 shows the amplitude vs time graph (A-Scan) from all other sensors with the transducer, 'A', acting as transmitter. The A-Scan shows the simulated damage signal (red), and the baseline signal (blue). The damaged signals for A-N, A-M and A-L are clearly attenuated when compared to the baseline (upper right of Figure 11). The simulated damage, SD2, lies on the direct path travelled by those signals, indicated that the attenuation is caused by SD2. Interestingly, the signal A-I shows similar attenuation on the second wave packet, representing the reflected signal (lower right of Figure 11), but no attenuation on the first wave packet, representing the direct path. This is clear evidence of the simulated damage, SD1, strongly suggesting that reflected signals can be used to identify and locate damage in the same way as direct signals.
